SUPER INSPECTOR

2025 TREC REI 7-6 SUPER INSPECTOR\*

18420 Blush Rose Rd  
Pflugerville, TX 78660

# PROPERTY INSPECTION REPORT FORM

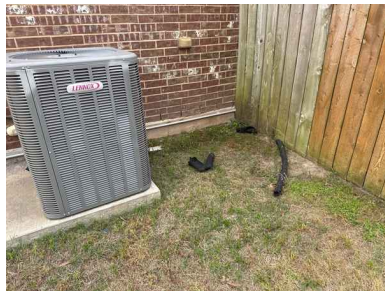
Right

There is soil erosion from roof runoff on the sides of the house. Roof gutters may need to be installed / cleaned out to help prevent soil erosion and to help divert drainage away from the foundation. This is reflected in the International Residential Building Code as follows: R801.3 Roof drainage. In areas where expansive or collapsible soils are known to exist, all dwellings shall have a controlled method of water disposal from roofs that will collect and discharge roof drainage to the ground surface at least 5 feet (1524 mm) from foundation walls.

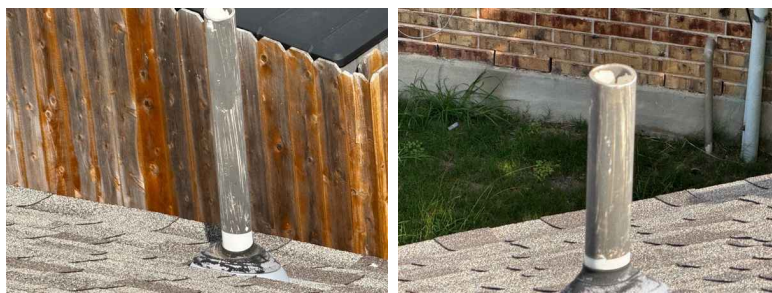
### 1: Paint sewer vent pipes

Unpainted sewer vent pipes were observed on the roof. PVC and neoprene will deteriorate where exposed to ultraviolet rays. Painting the vent pipe and neoprene auto caulk can help prevent deterioration caused by exposure to ultraviolet rays.

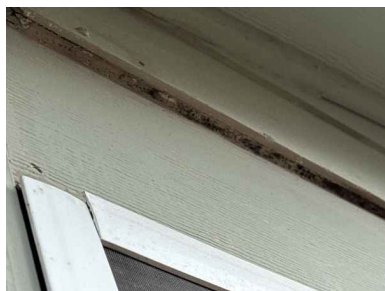
Left/Back

## 2: Algae was observed on the exterior veneer

Algae was observed on the veneer. This commonly occurs when roof runoff splashes off adjacent surfaces onto the veneer. Installing roof gutters or cleaning out roof gutters can help to prevent splash back from roof runoff. For second story walls near a roof section, occasionally cleaning with a mild bleach solution can help prevent staining.

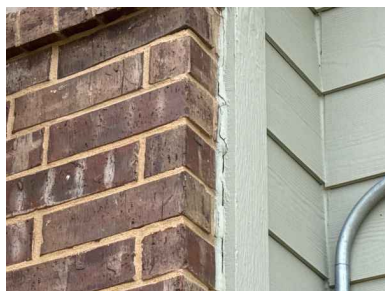
Right/Back

## 3: Seal caulk joints at wall trim

There are separated caulk joints at the exterior wall trim. The joints should be sealed to help prevent moisture penetration in those areas.

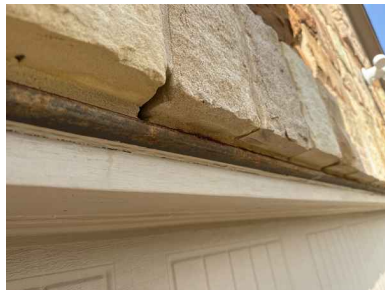
Garage

## 5: Rusted lintels

Rust was observed on the lintels. A lintel is a structural piece of material that sits flat atop and over an opening in a wall. Lintels are most commonly made from steel. Angle Iron, if left untreated, can rust and deteriorate. How to keep your steel lintels maintained: At the first signs of rust, be sure to have your lintels scraped, painted and caulked. Scrape and sand existing rust from the lintel, coat with an exterior grade paint, caulk the joint between the lintel and material above with a poly urethane caulk.

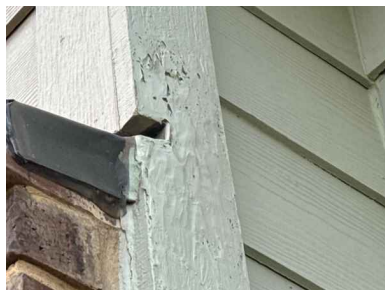
Right/Back

## 6: Moisture damage wall trim

There is moisture damage to the wall trim. The trim should be repaired or replaced, sealed, and painted to prevent moisture intrusion.

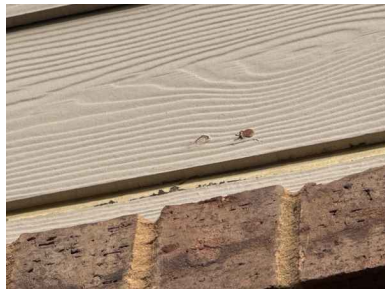
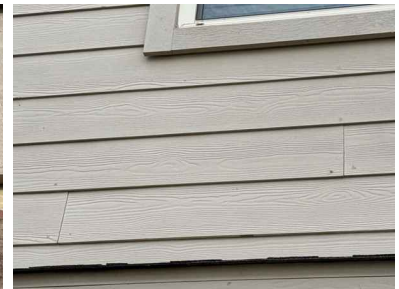
Various

There are cracks and separations at the caulk joints and exposed nails in the siding. The siding needs to be sealed at the joints to prevent moisture penetration in those areas. The exposed nails should be sealed as well.

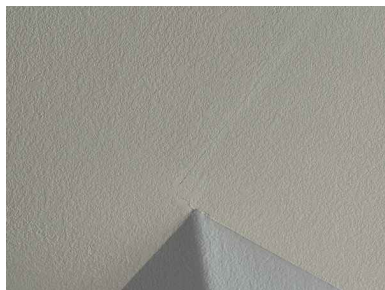
2nd Floor

### 1: Ceiling Common Cracks

There are common cracks on the ceilings. This can be caused by expansion and contraction of construction materials and/or structural movement. Repair as necessary.

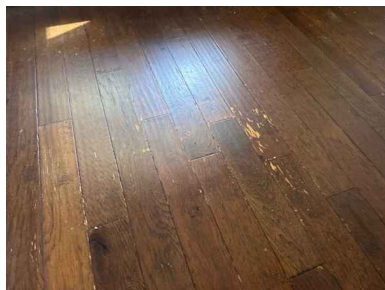
Office

There are areas of the wood floor that have mechanical damage. A qualified flooring contractor may be able to repair and match the finish to blend in.

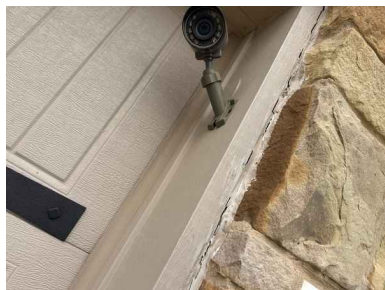
There are separated caulk joints at the overhead garage door casing. The joints should be sealed to help prevent moisture penetration in those areas.

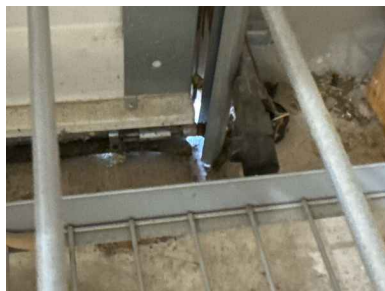
**2: Openings at garage door**

Openings were observed around the garage door casing. These areas should be sealed to help prevent pest intrusion.

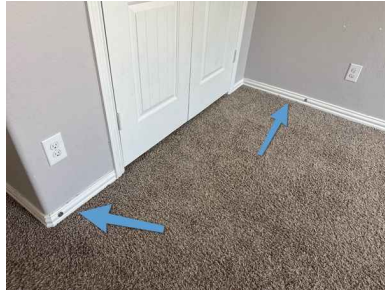
North Bedroom

There are doors without door stoppers or with non functioning door stoppers. The door stoppers should be repaired or replaced to protect walls adjacent to doors.

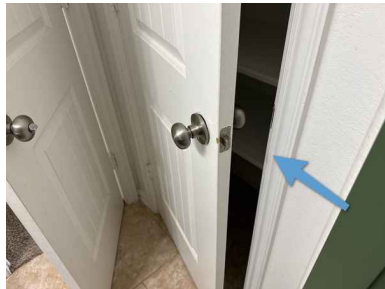
2nd Floor Hallway Bathroom

Doors have loose hardware. Repair or replace as necessary.

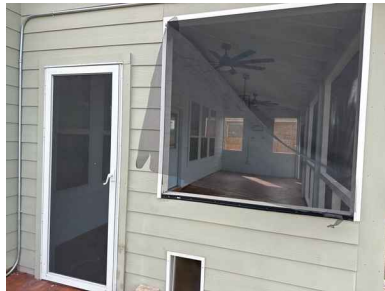
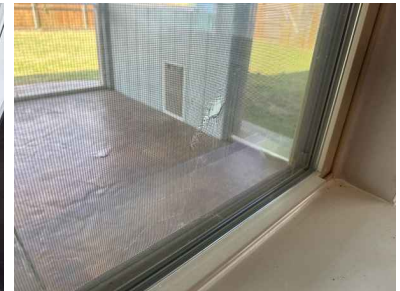
Back Porch

There are damaged window screens. Repair or replace as necessary.

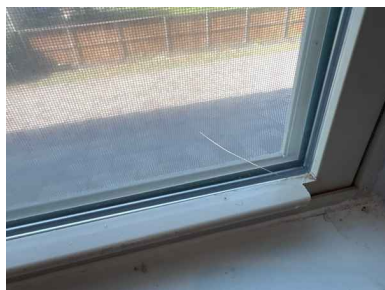
Master Bedroom

### 2: Window Glazing / Glass Broken

The window glazing / glass is cracked or broken. Repair or replacement is advised.

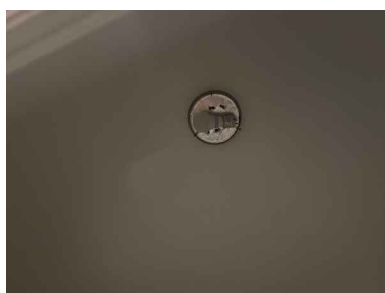
Pantry

There are light diffusers that are missing or not installed. A diffuser should be installed to ensure the bulb is properly protected.

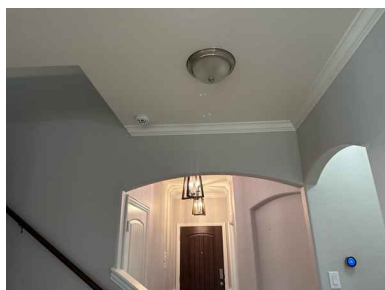
1st Floor

### 2: Lights did not activate

Lights did not activate when tested. This is often due to a burned out bulb or faulty ballast, but a faulty light fixture cannot be ruled out. It may also be related to an exterior light sensors preventing the light from coming on or missing ceiling fan remote if applicable. If replacing bulbs does not fix the problem, further evaluation and/or repair by a licensed electrician is recommended.

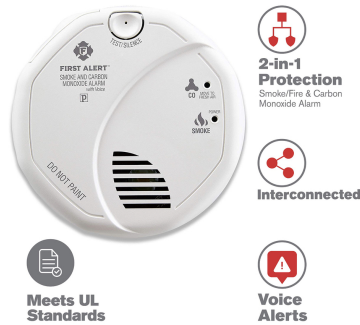
2nd Floor

monoxide alarms in dwelling units shall be **installed outside of each separate sleeping area in the immediate vicinity of the bedrooms**. When a fuel - burning appliance is located within a bedroom or its attached bathroom, a carbon monoxide alarm shall be installed within the bedroom. Carbon monoxide is an odorless, colorless, and tasteless gas that is near impossible to identify without a proper detector. It is caused by fuels not burning completely, including wood, gasoline, coal, propane, natural gas, gasoline, and heating oil. This unburned fuel can come from anything from clothes dryers, water heaters, and ovens to ranges, a fire - burning fireplace, or a car left running in a closed garage.

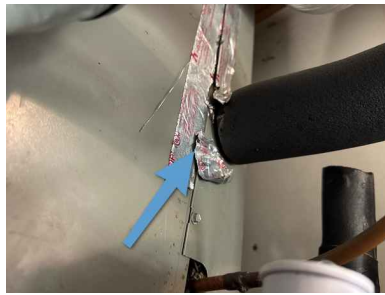
The suction side refrigerant pipe (cold pipe) insulation is not sealed to the cabinet. This condition will allow the pipe to sweat and drip into the overflow pan causing rust and deterioration over time. Seal the insulation to the cabinet for improved performance.

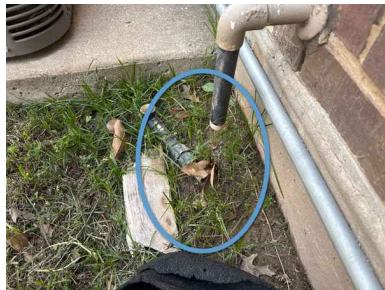
**3: Condensate drains near foundation**

The primary condensate drain line terminates near the foundation. This is an acceptable practice on this age of a house. However, this could excessively hydrate the soil in this area and may possibly cause foundation settling. It is recommended that an 18" to 24" extension be installed to remove the condensation produced by the AC unit from terminating next to the foundation.

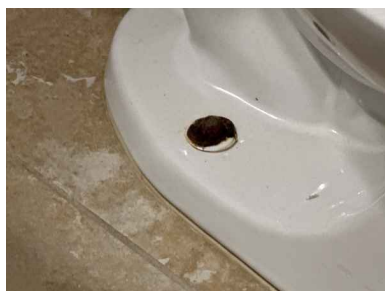
The toilet anchor bolts are not properly cut and covered. The bolts should be covered to help prevent rust and deterioration.

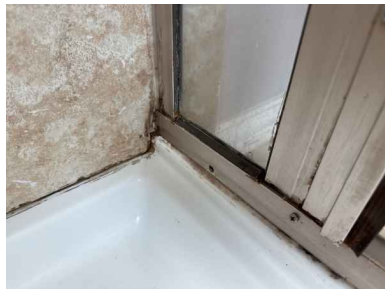
Master Bathroom

Fungal growth was observed on the tile grout in the bathroom shower enclosures. This can indicate moisture penetration and fungal growth behind the tile. Further evaluation and/or repair by a professional tile contractor is advised.

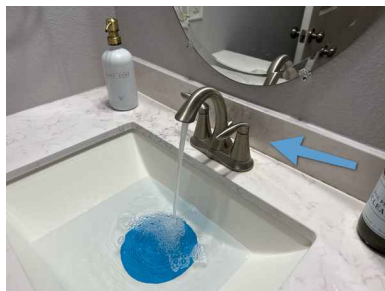
Half Bathroom

The interior faucet is difficult to operate. Repair or replace as necessary.

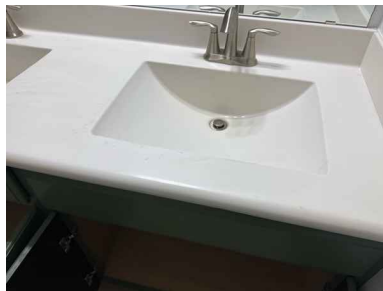
2nd Floor Hallway Bathroom

Drains drained slowly when tested. This may indicate a local blockage or a more extensive problem. Further evaluation and/or repair by a licensed plumber is advised.

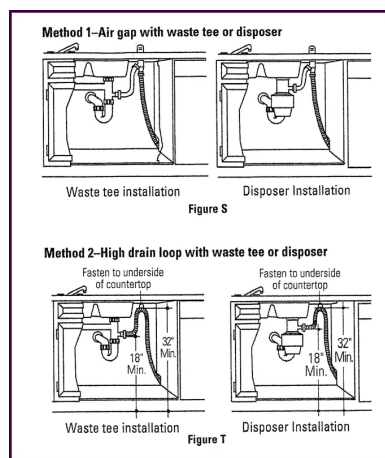
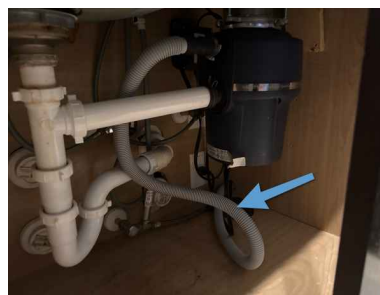
There is no air gap or sanitary loop in the dishwasher drain line to prevent waste water from contaminating the potable water supply. It is recommended that a sanitary loop or air gap be installed in the drain line.

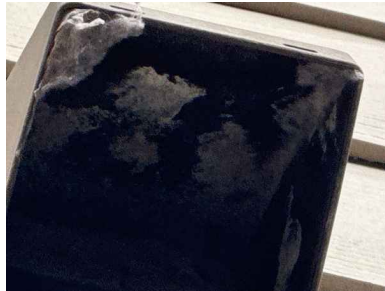
Lint accumulation was observed in the dryer vent cover. This may indicate the vent and/or cover need to be cleaned and screen removed. Lint accumulations can obstruct air flow and reduce dryer performance. Additionally, dryer vent obstructions are a fire hazard. It is recommend the vent be cleaned to ensure proper performance.

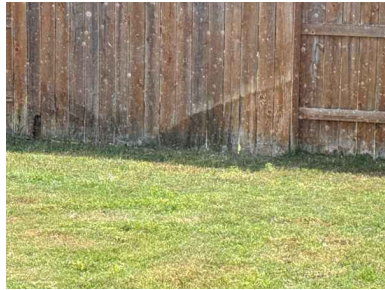
Zone 5

There are sprinkler heads spraying onto the fence. This can result in damage to the fence over time. The heads should be properly adjusted to direct spray away from the fence.

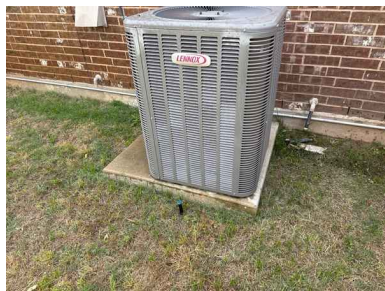
Zone 7

Heads are spraying on the AC condenser. This may prematurely deteriorate and/or cause damage to the condenser. Adjust heads as needed.
