Inspection Report  
SITE HAWK Home Inspections, LLC  
Jared L. Beard  
TREC Lic. # 20361

1180 1/2 Sol Wilson Ave, Austin, TX 78702

Prepared For:  
Sarah Searcy  
02-17-2026

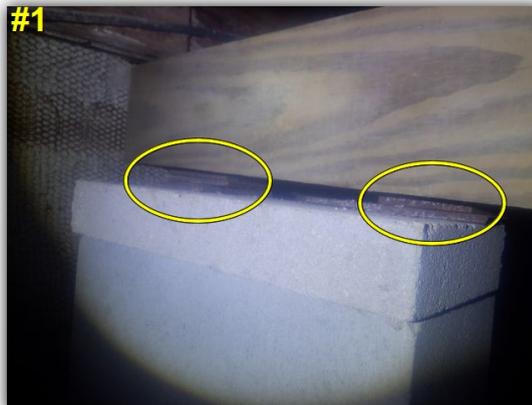
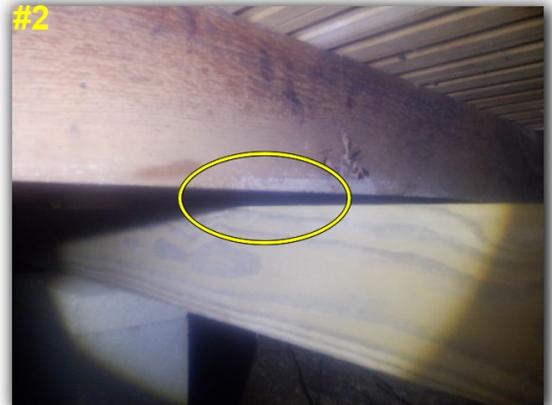
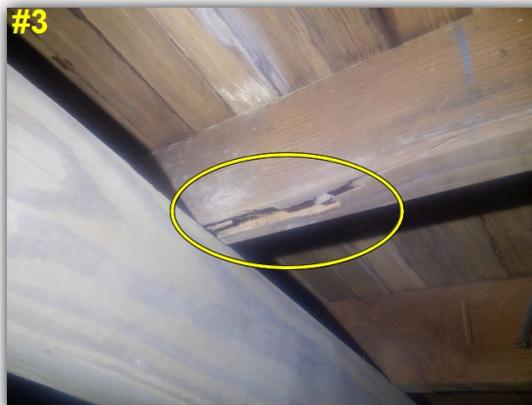
- Note - Some structural movement and/or settling noted (floors off level, cracking in drywall); however, the foundation appears to be supporting the structure at this time.

- Hairline cracks and minor damage were observed on the cement skirting around the perimeter of the foundation (see at left and right sides of home as example).

- One of the crawlspace vents in the foundation (at left side) is missing a cover.
- Recommend adding a vapor barrier to the soil in the crawlspace under the home to better limit moisture buildup.

- Some of the cement block have settled in the crawlspace and should be leveled where needed (see near center of crawlspace as example).
- There are gaps between a few of the piers and beams in the crawlspace. There are also gaps between a few of the floor joists and the beams below them as well (see near front right corner, front left, and front right of crawlspace as example) (**see photo #1 & 2 below**). Re-shim (with proper metal shims) where needed.

- There was previous termite damage observed on some of the framing members in the crawlspace under the home (**see photo #3 below**). There were two floor joists found that were overly damaged and in need of replacement (see near front right side of crawlspace as example). Replace damaged framing members where found to be needed.

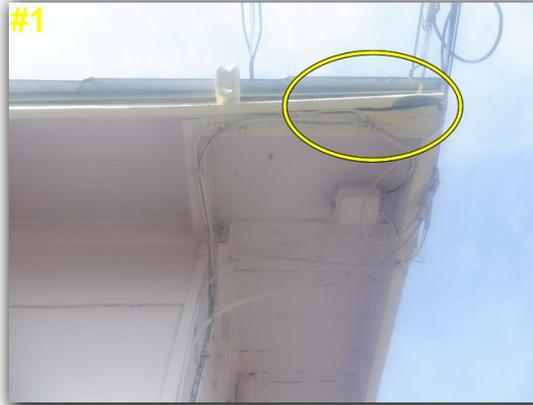
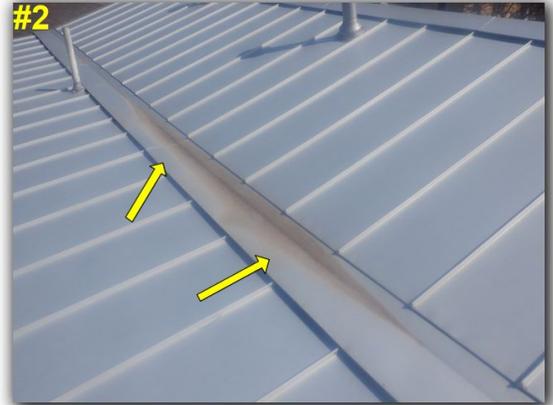
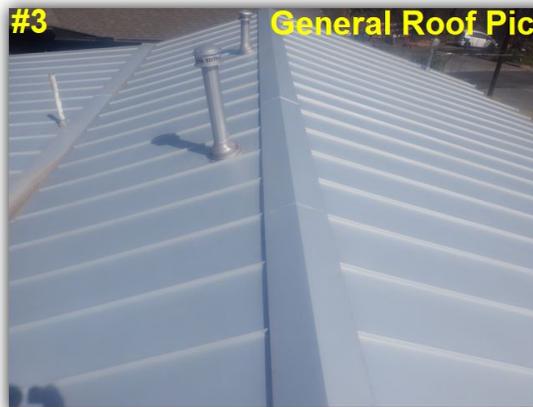
- The roof fascia appears to be pulling outwards at the front right corner of the home, where electrical wiring is secured (**see photo #1 below**). Needs to be better fastened.
- Recommend caulking/sealing the seams and splits in the exposed wood roof decking at the outer edges of the roof (at left and right sides of home) and re-paint where needed to better prevent further weathering or damage.
- There are small dents on the metal roofing panels at several areas, which is most likely from hail. Note -These dents are minor and not believed to be affected the integrity of the roofing material.
- The B-vent at upper rear of roof (near ridge) is too short/close to the roof covering. This vent

should ideally extend at least 2 ft above any portion of the roof within 10 ft.

- Note - There is evidence of minor water ponding across the metal flashing at the rear of the roof, between the lower and upper roof sections (dry at time of inspection) (see photo #2 below).

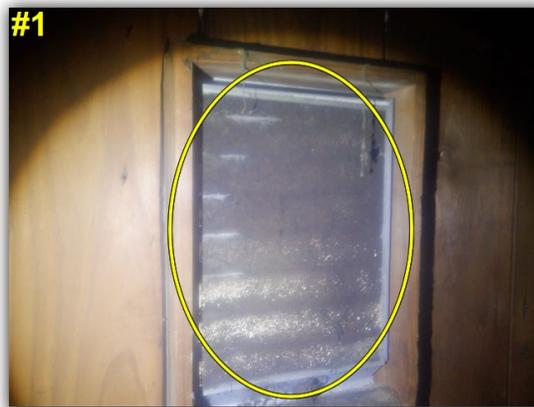
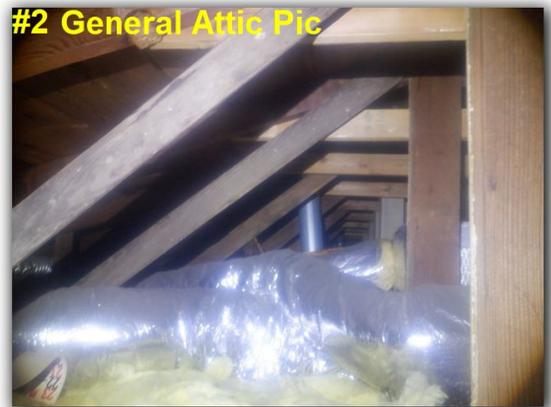
- Note - The attic access (at ceiling of middle bedroom closet) is very small for access.
- The screening on the gable vents in the attic are clogging with dust (**see photo #1 below**). Recommend cleaning or replacing the screening for optimal air flow.

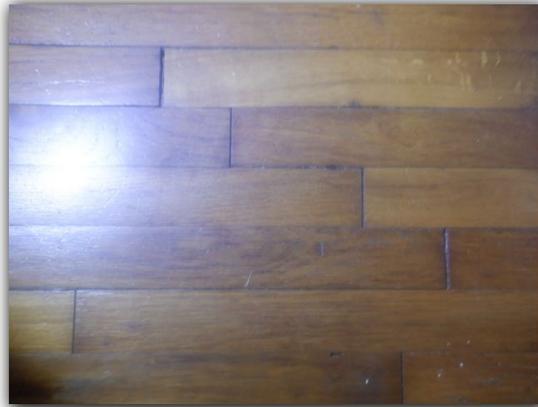
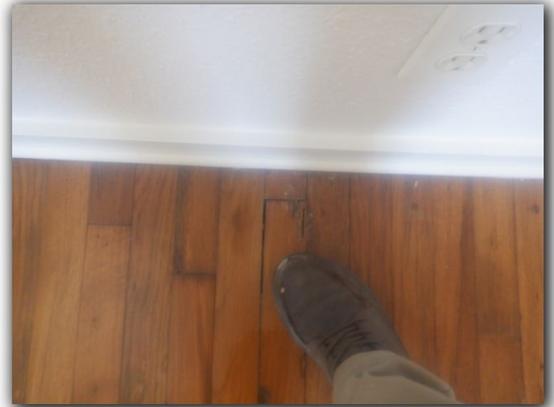
- The wood flooring of the home has wear and minor damage, mainly due to age. There are gaps between many of the floor boards and there is minor damage to the flooring at some areas that need to be patched/repared. There are also one or more areas of the floor that are soft when walked on (see near wall at right side of floor in left side bedroom as example) **(see photos below)**.

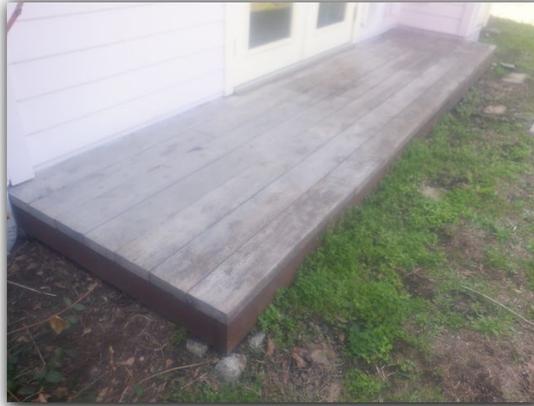
- shed (dented panels, some panel seams opened).
- The outer perimeter of the rear patio deck has direct wood to ground contact (**see photo below**). This can cause the wood to rot at an accelerated rate. Note - No rot was observed here at time of inspection.

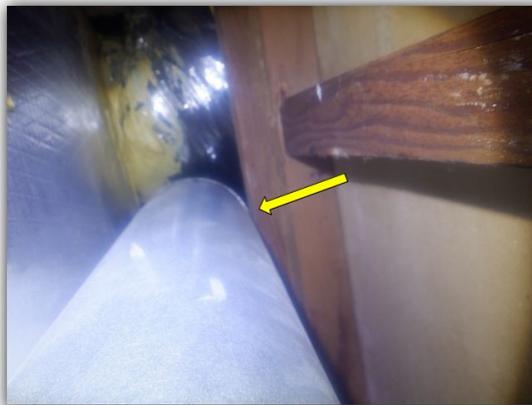
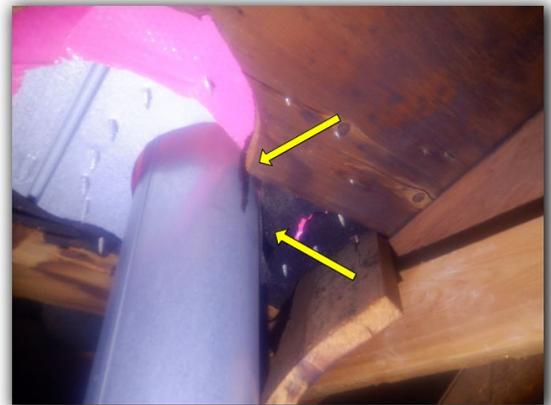
- The ceiling to the furnace closet is open to the attic. By today's standards, this should have a fire stop (drywall or plywood) installed for fire safety.
- The furnace flue is in contact with flammable materials (wood framing and HVAC plenum in the closet above the unit, and roof decking and underlayment in the attic where it penetrates the roof) **(see photos below)**. There needs to be a gap made between the flue and flammable material for fire safety.
- The furnace closet does not currently have proper combustion air. Right now there is no lower combustion air vent and the ceiling is open to the attic. If the ceiling is sealed (for a fire stop), lower and upper combustion air vent will need to be added. The furnace closet door will also need weather-stripping added.

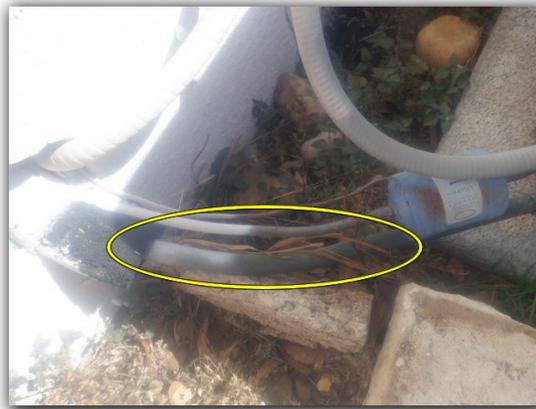
- The AC unit specifies a max amp breaker of 15 amps and a 30 amp appears to be present in the exterior electrical panel. This breaker may be oversized and may need to be replaced **(electrician or HVAC tech to confirm)**.
- The refrigerant line needs to be re-insulated at the exterior AC unit **(see photo below)**.
- Note - The coolant being used for the AC unit has been recently phased out. It can be difficult to get and expensive to fill if available.

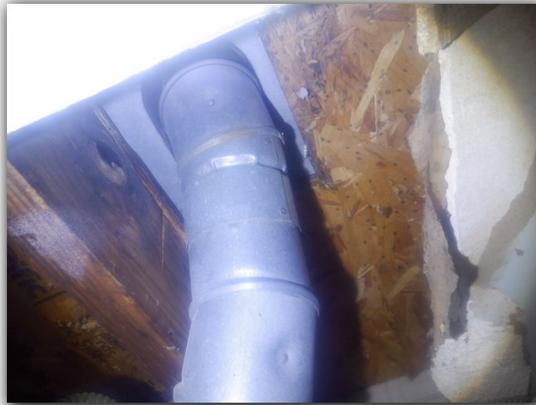
- An emergency pan is present under the water heater, but it just drains to the floor of the closet. Ideally, the pan should be plumbed to the exterior to better prevent water damage to the water heater closet should the unit ever leak.
- The ceiling to the water heater closet is open to the framing above. By today's building safety standards, this ceiling should have a fire stop (drywall or plywood) installed for fire safety.
- The water heater is currently missing an upper combustion air vent. Note - It is currently getting its combustion air from the ceiling of the closet being open and an open soffit at the front. If the ceiling is sealed (for a fire stop), an upper combustion air vent will need to be added.
- There is some previous water damage to the base of the water heater closet. Note -This area tested dry at time of inspection.
