Barfield Home Inspection Services

PROPERTY INSPECTION REPORT FORM

Concerning: 11602 Sterlinghill Dr Austin , TX 78758

Inspection Date: 12-1-22

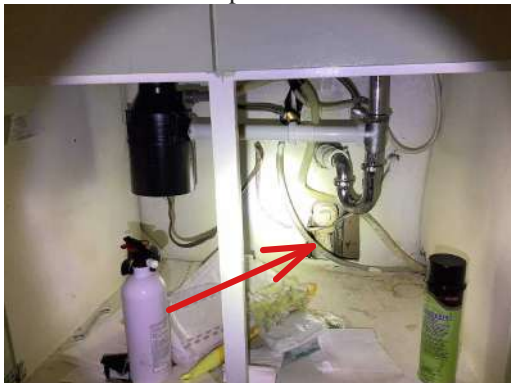
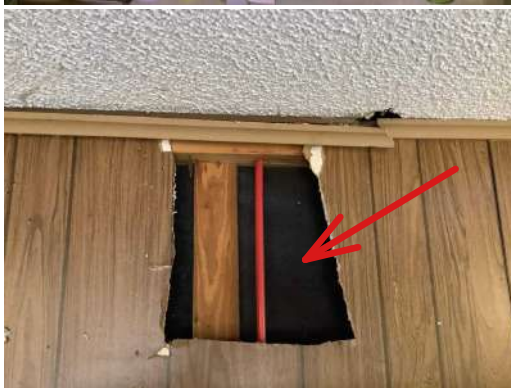
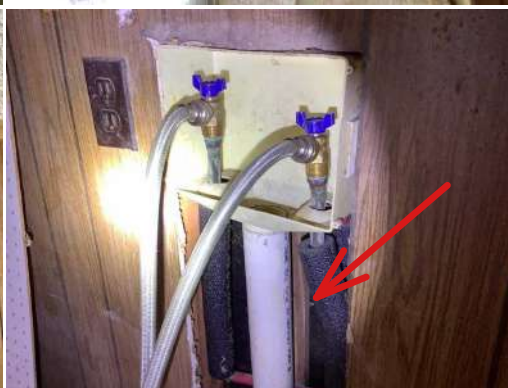
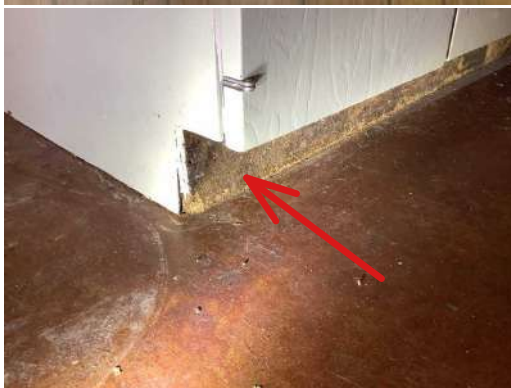
Comments: The interior walls have been recently painted.
 There is a hole in the sheet rock at the kitchen area under sink cabinet.
 The masonry fireplace hearth is separated at the left side sheet rock seam.
 The inspection of the interior walls of the garage area was limited due to stored items and wall coverings.
 There are holes in the wall material at the rear garage wall, near washing machine connection.
 There is a break in the sheet rock at the rear W corner breakfast nook area corner seam.
 There is deterioration of the toe kick plate at the kitchen cabinet.
 All other visible components were found to be in satisfactory condition at the time of inspection.

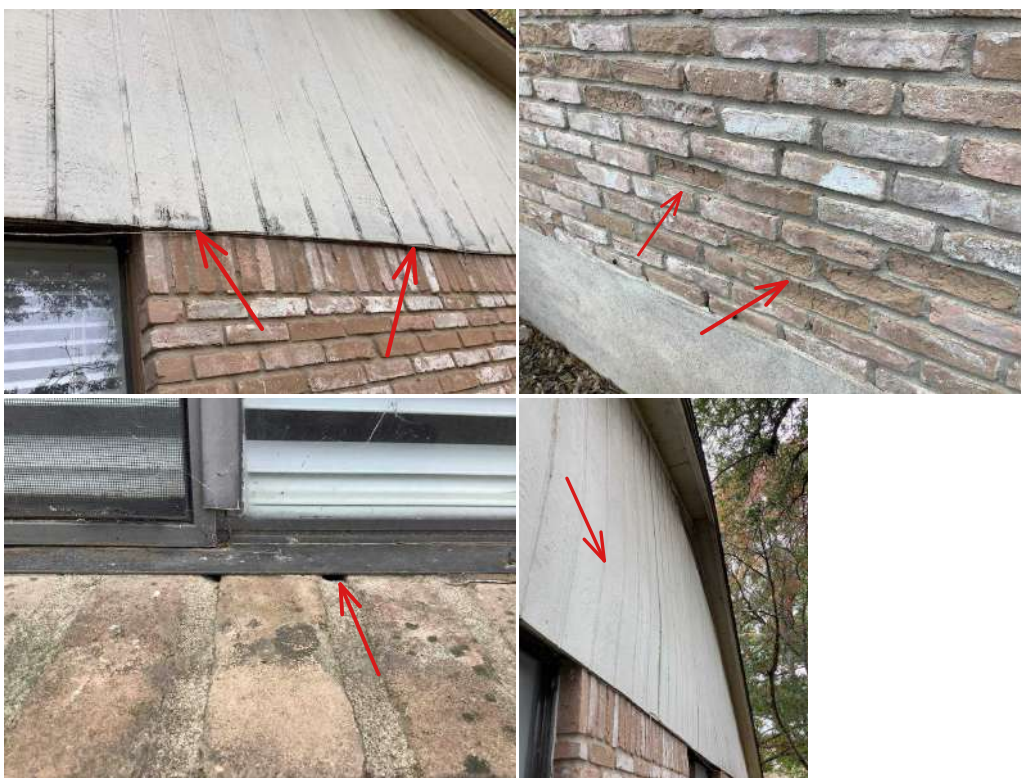
There is deterioration of the trim/fascia boards at the rear N corner wall.
 There is damage to the siding and frieze board trim at the front SE upper wall.
 Recommend applying additional sealant to seams at the exterior wall siding and trim boards.
 All other visible components were found to be in satisfactory condition at the time of the inspection.

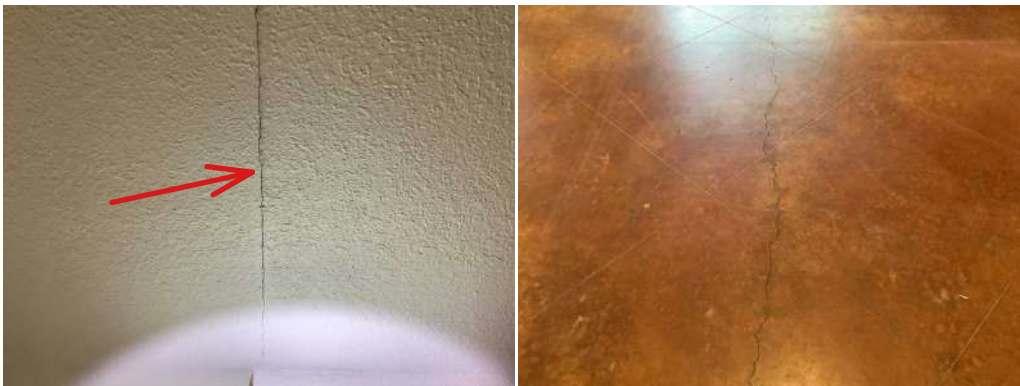
Comments: The inspection of the interior floors of the garage area was limited due to stored items. There are breaks in the sheet rock seams at the kitchen ceiling. There are cracks in the concrete floors at the master bathroom closet, breakfast nook area and living area. All other visible components were found to be in satisfactory condition at the time of the inspection.

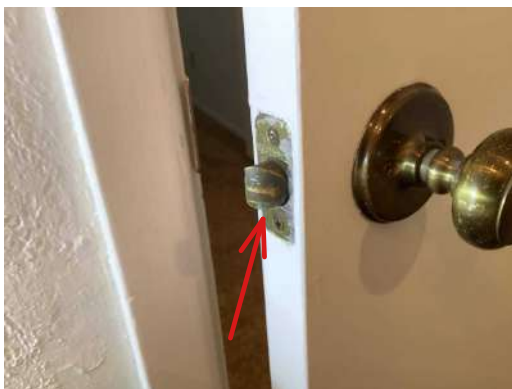
Comments: The hallway bathroom door does not latch properly due to latch installed backwards.
The bifold doors at the front S guest bedroom closet rub at the carpet and do not open and close properly.
The front E guest bedroom door is missing the door stop.
The master bedroom door frame is out of square and the door walks open when ajar.
All other visible components were found to be in satisfactory condition at the time of the inspection

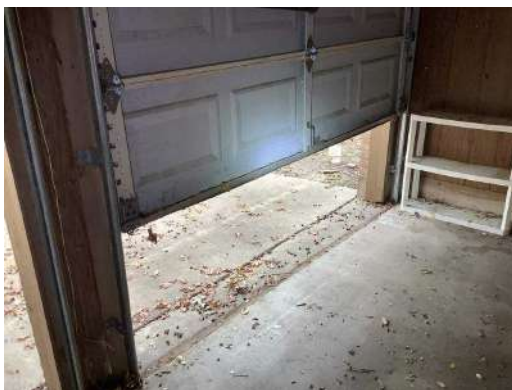
Comments: The rollers of the S side garage door are not rolling on the tracks properly, and the door does not open all the way.
Recommend contacting a garage door technician to address this issue.

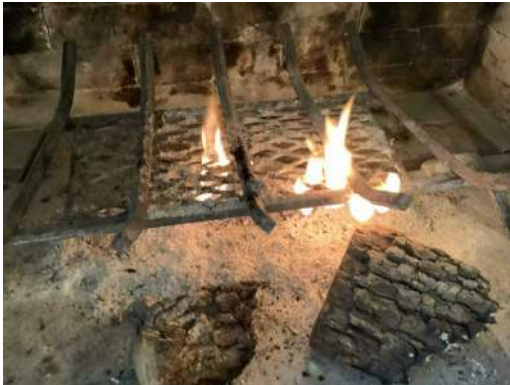
Comments: The inspection of the firebox was limited due to ash and debris present at the time of inspection. The gas starter wand pipe is clogged and does not function properly. All other visible components were found to be in satisfactory condition at the time of inspection.

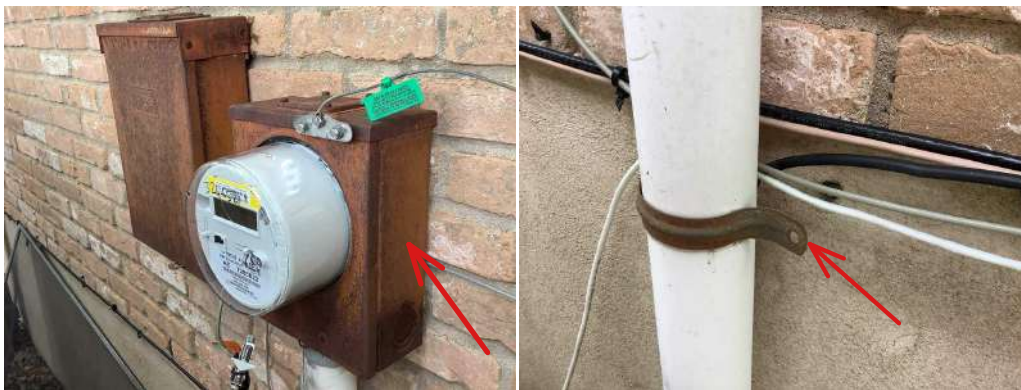
Comments: The service entrance meter box is corroded, and no longer secured properly at the exterior wall. All other visible components were found to be in satisfactory condition at the time of the inspection.

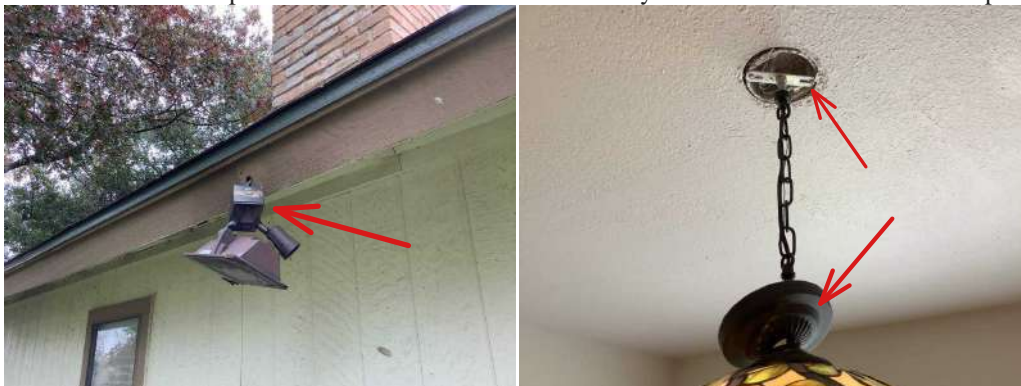
Comments: The rear exterior flood light is no longer secured properly at the fascia board, and does not function
There are bulbs not functioning at the kitchen ceiling recessed lights and the kitchen sink light.
There are bulbs not functioning at the master bedroom ceiling fan.
There is a bulb not functioning at the fireplace recessed light.
There is a bulb not functioning at the rear exterior wall flood light.
The light fixture at the breakfast nook area
The fluorescent light fixtures in garage did not appear to function.
The HVAC closet light is not secured properly and did not function. Unable to locate switch for this light.
All other visible components were found to be in satisfactory condition at the time of the inspection.

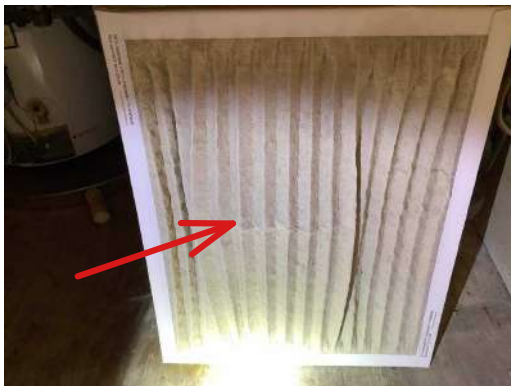
Comments: The return air filter at the unit in the hallway closet is dirty / clogged and should be replaced.
The return ducts lines appear to be dirty at the inside walls.
Recommend having a licensed repair contractor clean and and further evaluate the duct lines.
All other visible components were found to be in satisfactory condition at the time of inspection.

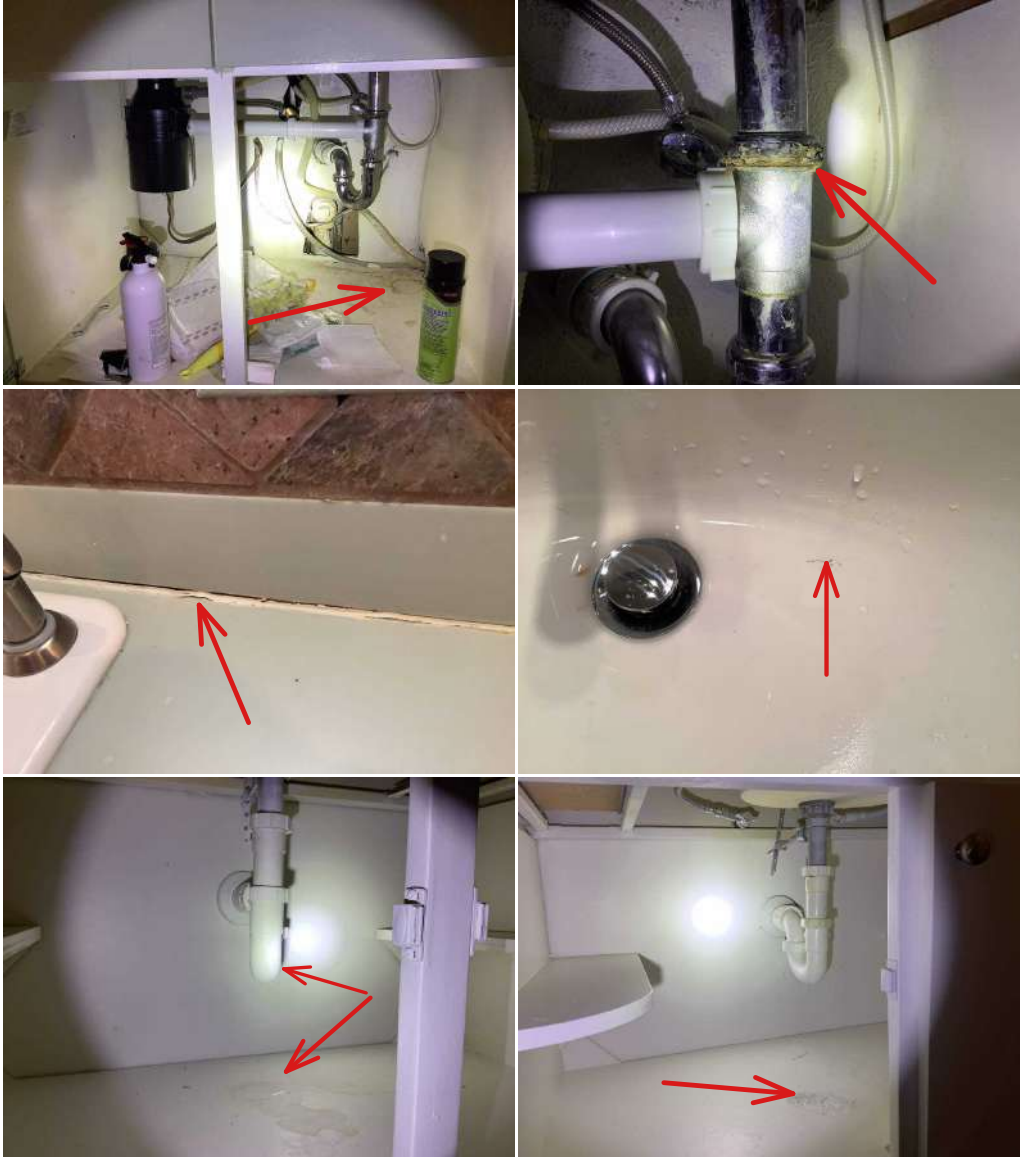
Comments: The kitchen sink faucet does not shut off properly at the faucet handle.
There are stains and deterioration at the under sink cabinet area of the kitchen sink.
There is corrosion and deterioration of the kitchen sink drain trap pipe fitting.
The caulking joint at the back splash of the kitchen sink is cracked and needs additional sealant.
There is damage to the sink bowl finish at the hallway bathroom.
The master bathroom sink on the left leaks at the drain line.
There is deterioration at the under sink cabinet areas of both master bathroom sinks.
Recommend contacting a licensed plumbing contractor to address these issues and to further evaluate.

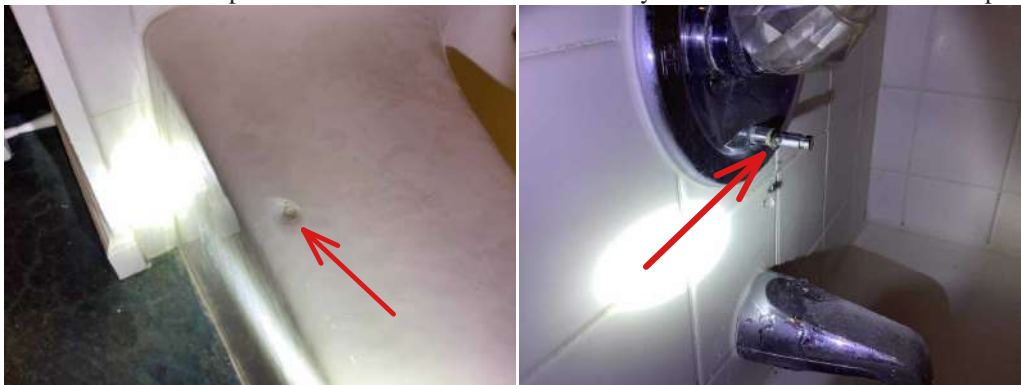
Comments: There is damage to the finish at the hallway bathroom tub.
The shower diverter stem for the hallway bathroom tub faucet leaks when tub faucet is in use.
All other visible components were found to be in satisfactory condition at the time of the inspection.

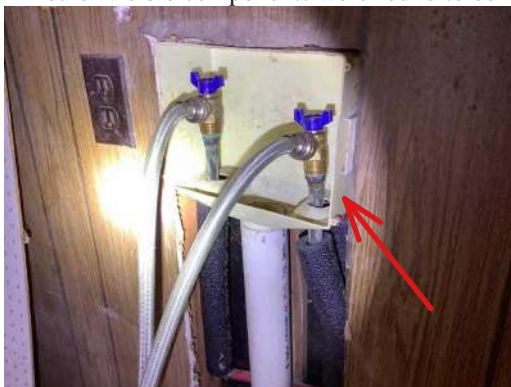
Comments: The washing machine connection surround is not secured properly, due to missing wall material at this area.
All other visible components were found to be in satisfactory condition at the time of the inspection.

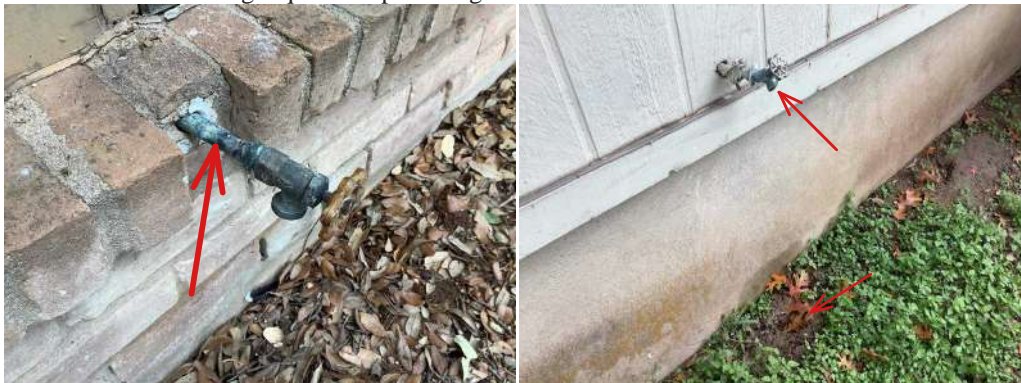
Comments: The front SE exterior hose bibs are not sealed and secured properly at the wall penetration, or insulated properly to prevent freezing.
The hose bib at the rear NW wall does not shut off properly and drips.
The exterior hose bibs do not have back-flow prevention devices.
Recommend contacting a qualified plumbing contractor to address these issues and further evaluate.

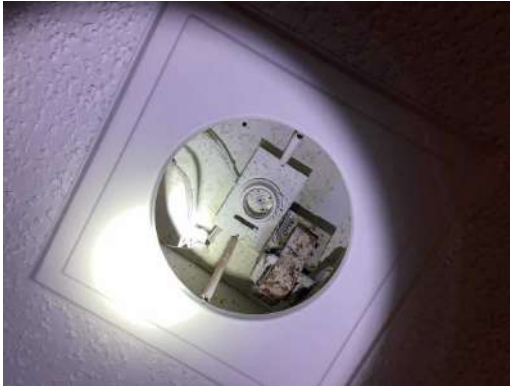
Comments: The master bathroom exhaust fan motor does not function.
The master bathroom heater bulb is missing.
All other visible components were found to be in satisfactory condition at the time of inspection.

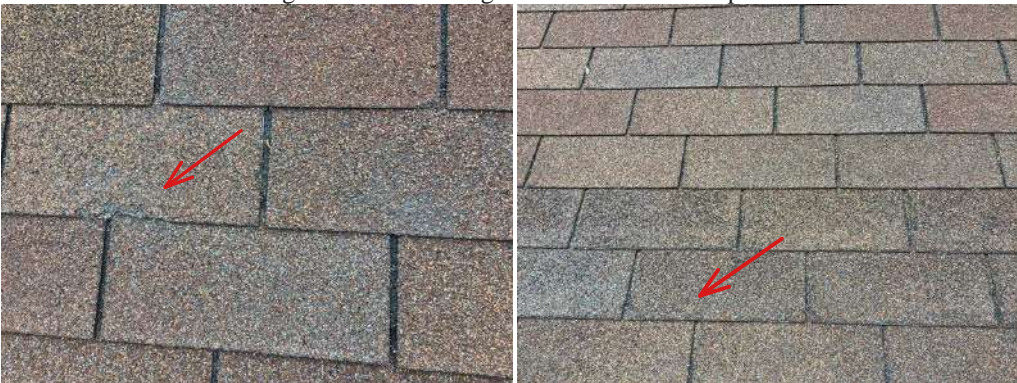
C. Roof Covering Materials There are damaged and deteriorated shingles at the rear NW side of the roof cover. There have been previous repairs made to the roof cover at the SW, NW, and NE sides of the roof cover. Moisture stains at the roof decking indicate possible leaks at the roof cover. Recommend contacting a certified roofing contractor to make repairs to the roof and to further evaluate the roof.

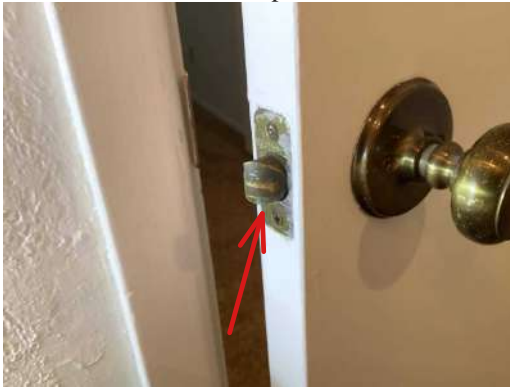
- G. Interior Doors The hallway bathroom door does not latch properly due to latch installed backwards.
The bifold doors at the front S guest bedroom closet rub at the carpet and do not open and close properly.
The front E guest bedroom door is missing the door stop.
The master bedroom door frame is out of square and the door walks open when ajar.
All other visible components were found to be in satisfactory condition at the time of the inspection

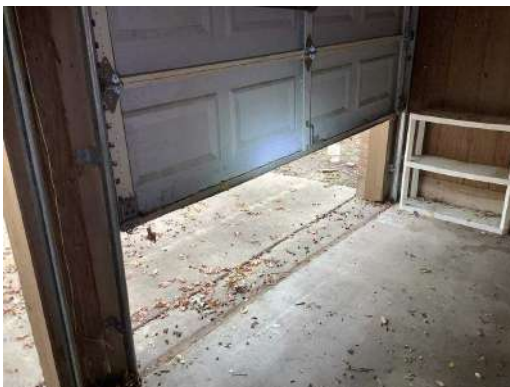
- G. Exterior Doors The garage to living area door is not a proper fire rated door.
All other visible components were found to be in satisfactory condition at the time of the inspection.
- G. Garage Doors The rollers of the S side garage door are not rolling on the tracks properly, and the door does not open all the way.
Recommend contacting a garage door technician to address this issue.

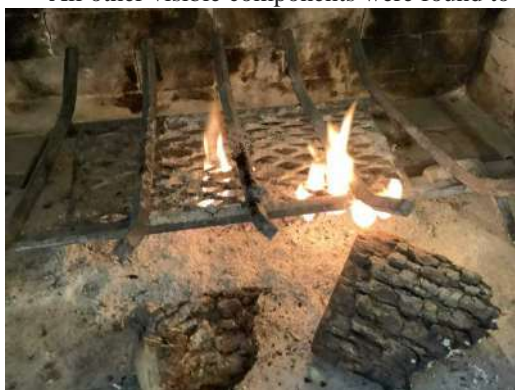
- J. Fireplaces and Chimneys The inspection of the firebox was limited due to ash and debris present at the time of inspection.
The gas starter wand pipe is clogged and does not function properly.
All other visible components were found to be in satisfactory condition at the time of inspection.

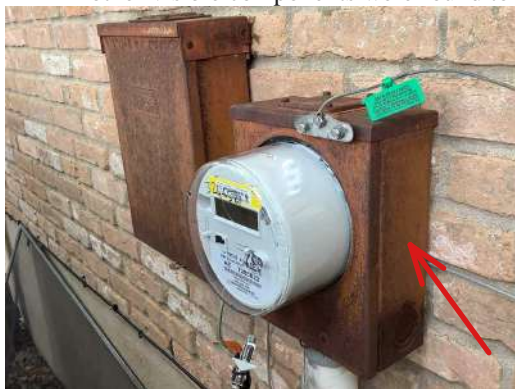
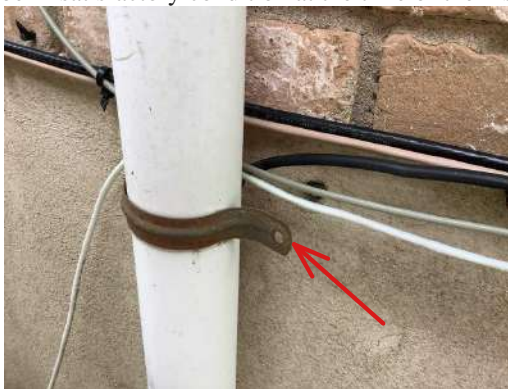
- A. Service Entrance and Panels The service entrance meter box is corroded, and no longer secured properly at the exterior wall.
All other visible components were found to be in satisfactory condition at the time of the inspection.

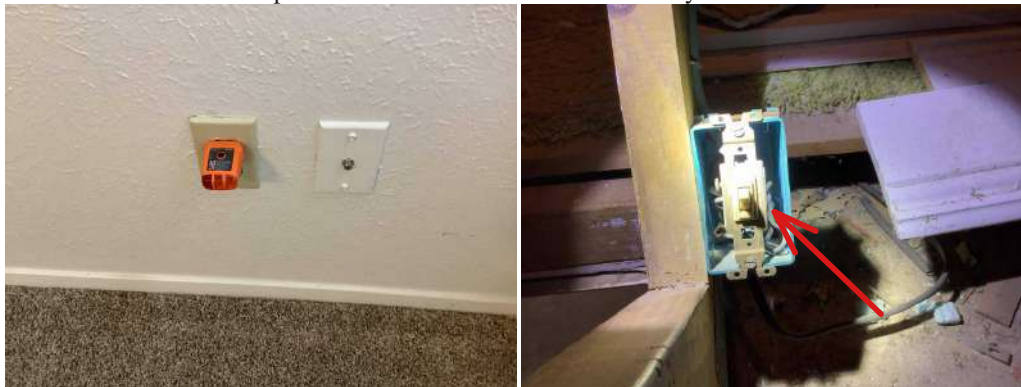
- B. Outlets and Switches: The upper socket at the rear W corner master bedroom wall outlet did not function when tested. This outlet may be switched on at the light switch, however the switch did not appear to function for powering the outlet. The dimmer switch for the NE living area wall sconces does not function properly. There is a missing light switch plate at the attic area. All other visible components were found to be in satisfactory condition at the time of the inspection.

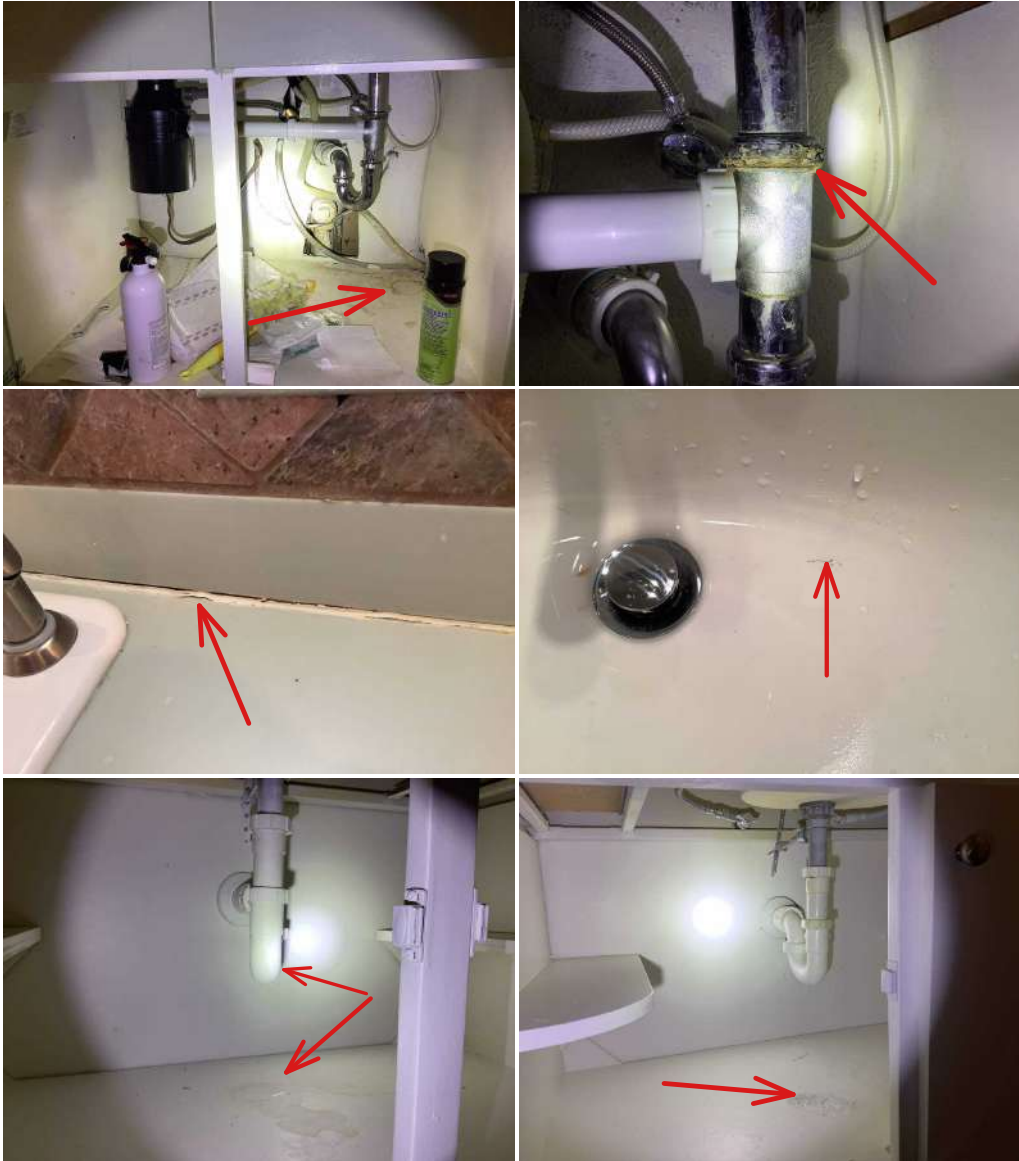
- A. Sinks The kitchen sink faucet does not shut off properly at the faucet handle.
There are stains and deterioration at the under sink cabinet area of the kitchen sink.
There is corrosion and deterioration of the kitchen sink drain trap pipe fitting.
The caulking joint at the back splash of the kitchen sink is cracked and needs additional sealant.
There is damage to the sink bowl finish at the hallway bathroom.
The master bathroom sink on the left leaks at the drain line.

Recommend contacting a licensed plumbing contractor to address these issues and to further evaluate.

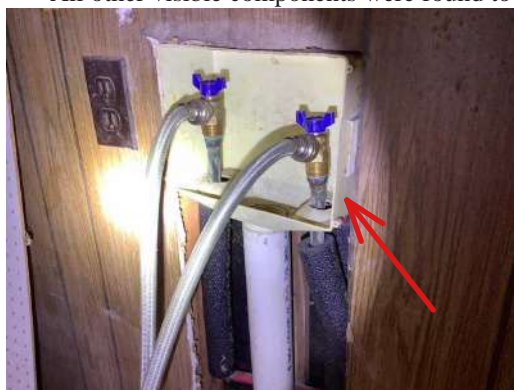
A. Washing Machine Connections The washing machine connection surround is not secured properly, due to missing wall material at this area.

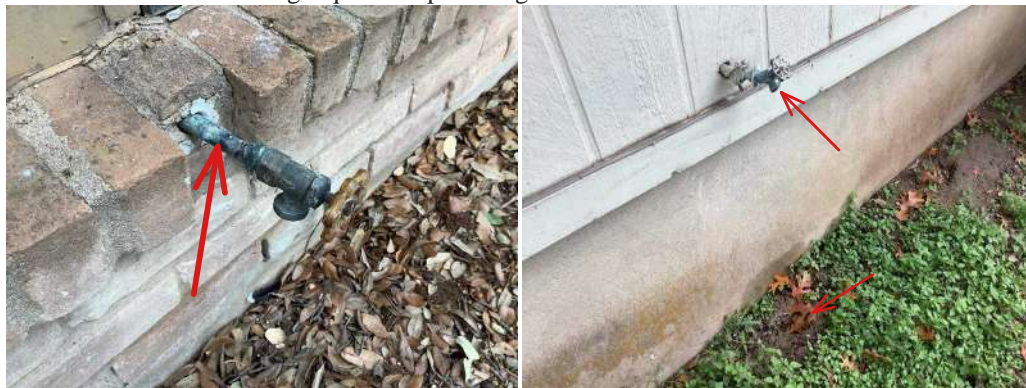
A. Exterior Plumbing Fixtures The front SE exterior hose bibs are not sealed and secured properly at the wall penetration, or insulated properly to prevent freezing.

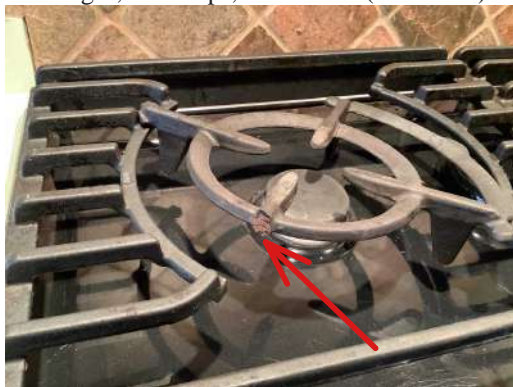
D. Ranges, Cooktops, and Ovens The rear left range burner grate is damaged. All other visible components were found to be in satisfactory condition at the time of inspection.

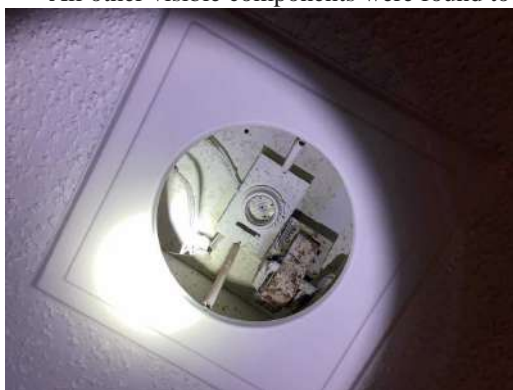
- F. Mechanical Exhaust Vents and Bathroom Heaters The master bathroom exhaust fan motor does not function.
The master bathroom heater bulb is missing.
All other visible components were found to be in satisfactory condition at the time of inspection.
