**Barfield Home Inspection Services**  
**1100 Rutherford Dr**  
**Driftwood, TX 78619**  
**(512) 350-0123**

## PROPERTY INSPECTION REPORT FORM

Concerning: 6905 Estana Ln Austin, TX 78739

Inspection Date: 07/27/2026

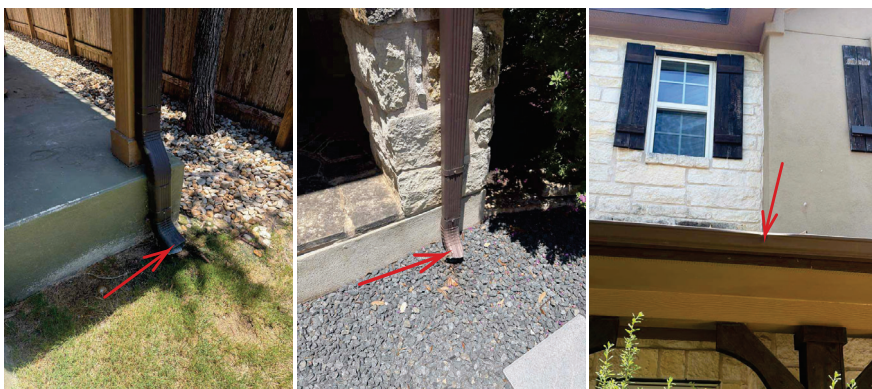
There is a dent in the gutter trough at the front lower eave.

Added new downspouts

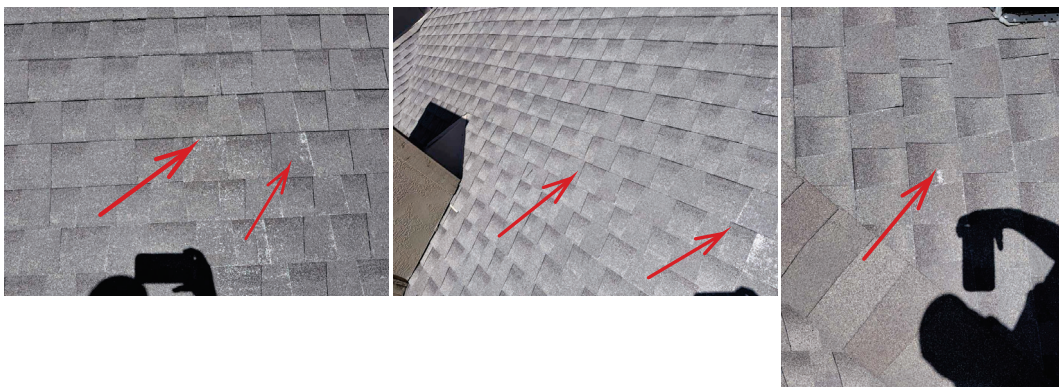
Comments: There is significant damage and deterioration to the shingles throughout the roof cover.

Recommend contacting a certified roofing contractor to make repairs to the roof and to further evaluate the roof.

Replaced the roof

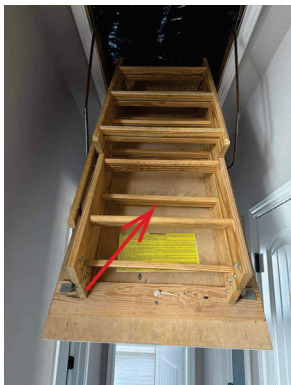
The upstairs pulldown ladder should be insulated at the attic side to prevent heating and cooling loss.

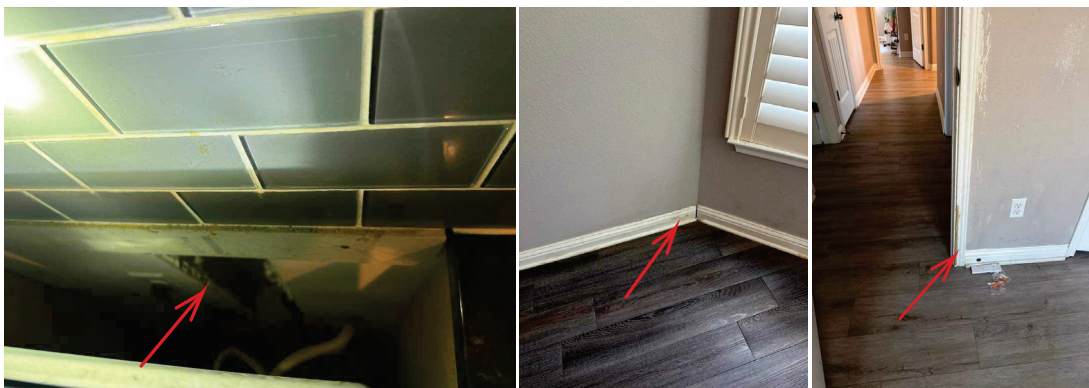
There is deterioration of the baseboard molding at the master bedroom rear wall.

Theres deterioration and damage to the wall trim at the upstairs northside middle bedroom.

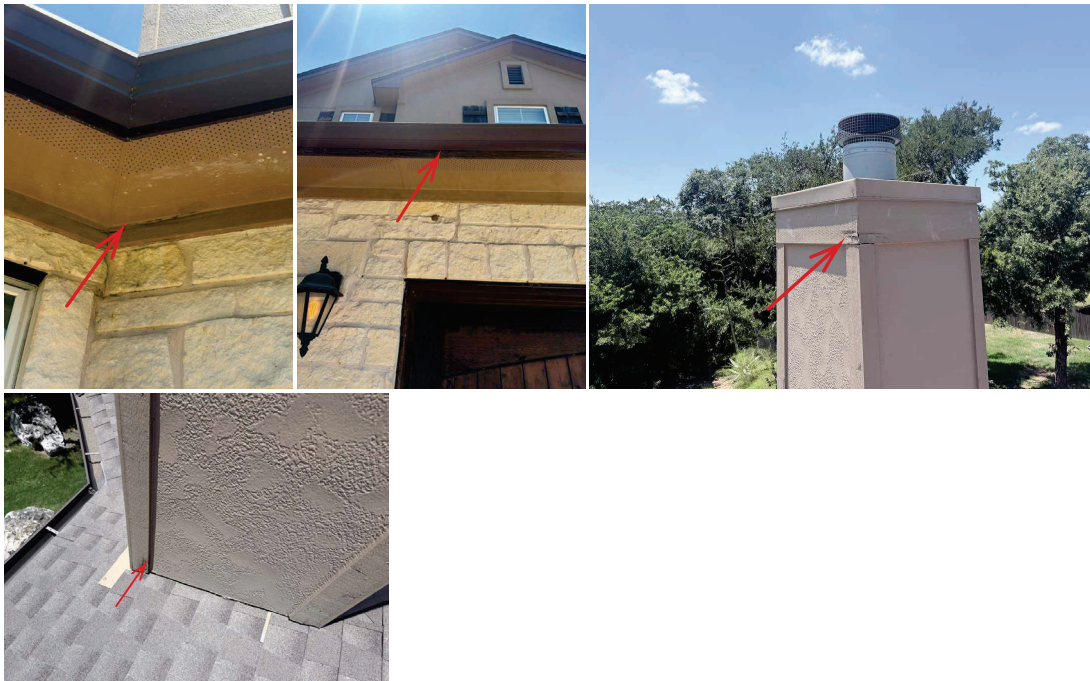
Comments: There is deterioration of the trim board at the fascia trim rear lower eave.  
There is deterioration of the trim board at the upper chimney wall.  
There are breaks in the masonry veneer mortar joints at the front garage door wall.  
All other visible components were found to be in satisfactory condition at the time of the inspection.

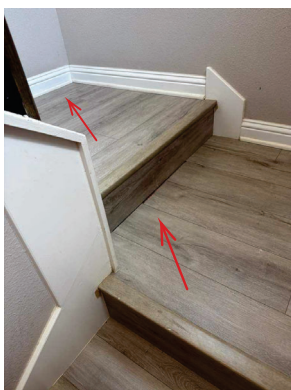
Comments: The inspection of the interior walls structure and garage area was limited due to stored items, wall coverings and furniture.  
There are loose flooring material at the middle stairway landing area.  
All other visible components were found to be in satisfactory condition at the time of the inspection.

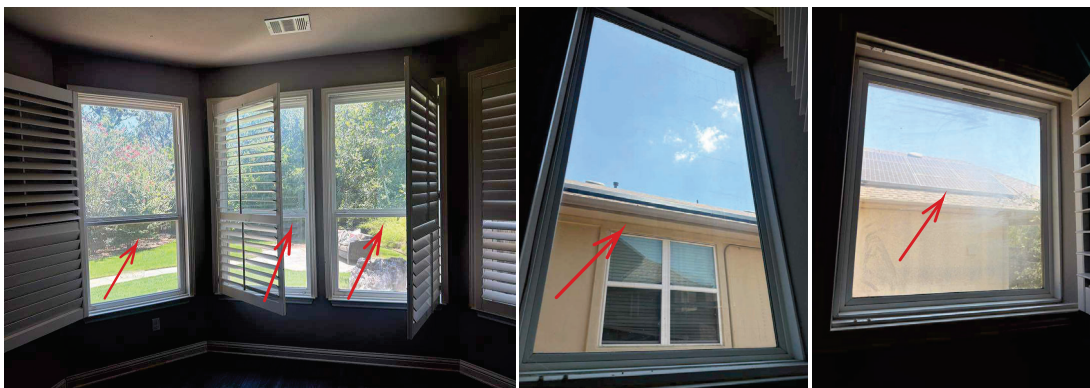
Comments: The inspection of the windows was limited due to window coverings and stored items.  
There are three windows at the master bedroom bay wall that have lost the thermal seal and moisture has penetrated between the glass panes.  
The window at the stairwell area has lost the thermal seal and moisture has penetrated between the glass panes.  
The far right window at the upstairs living room area had lost the thermal seal and moisture has penetrated between the glass panes.  
The window screens were not installed at the time of the inspection.  
All other visible components were found to be in satisfactory condition at the time of inspection.

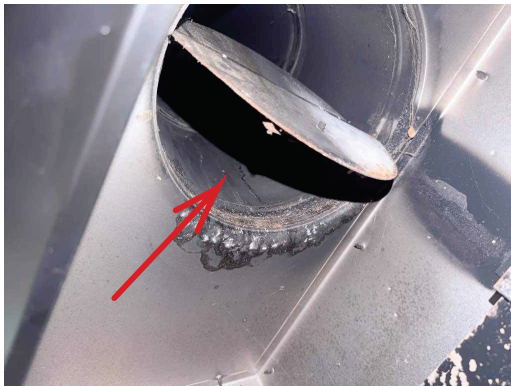
Comments: There is a buildup of soot and carbon residue in the flue.  
It is recommended that a C clamp be installed on the flue damper to keep the flue from completely closing.  
Recommend having the flue cleaned and evaluated before further use.

Had chimney flue cleaned

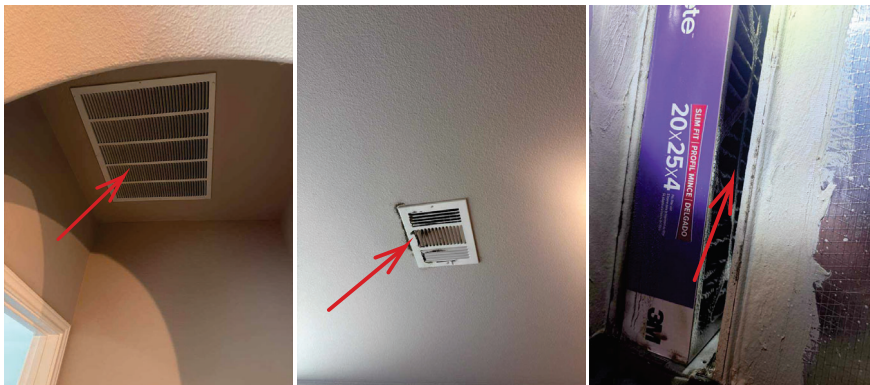
The air return filter at the unit in the attic area is dirty and clogged and recommend replacing.

Based on the heavy buildup of dirt and stains at the supply vents and air return filter, it is recommended to have the HVAC system cleaned and further evaluated by a licensed HVAC contractor.

Had vents cleaned

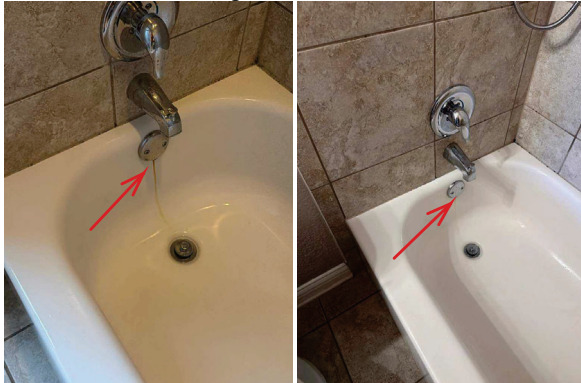
Comments: There is rust at the upstairs guest bathroom tubs at the drain scuppers.

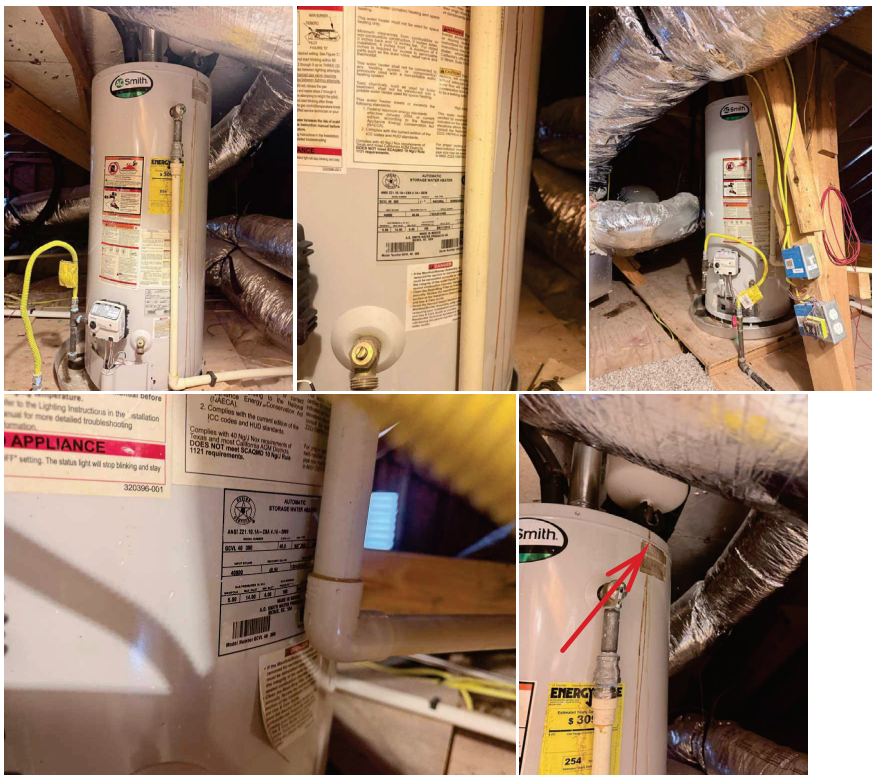
Comments: The structure supplied with 2-40 gallon gas water heaters that are installed at the upstairs attic area. There are rust stains at both water heater units, indicating previous or current possible leaks at the units. All other visible components were found to be in satisfactory condition at the time of inspection. Recommend having the water heater unit serviced and further evaluated by a licensed repair contractor.

*Had both water heaters replaced August 2026*

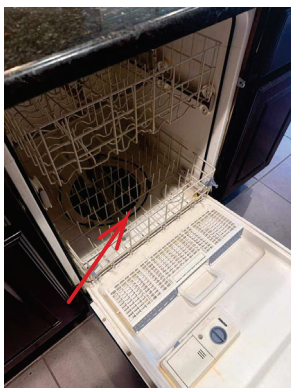
Comments: There is rust on the racks of the dishwasher.

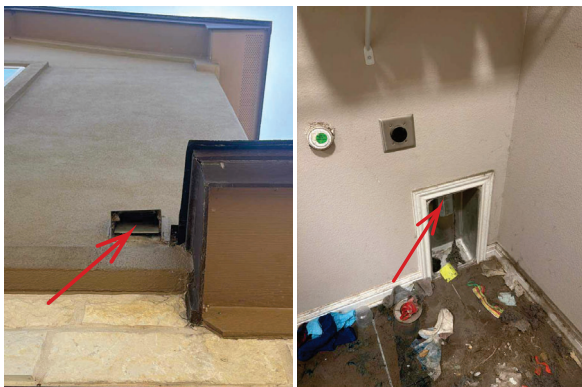
Comments: The dryer vent duct pipe is clogged with lint and should be cleaned before further use.

Had dryer vent cleaned

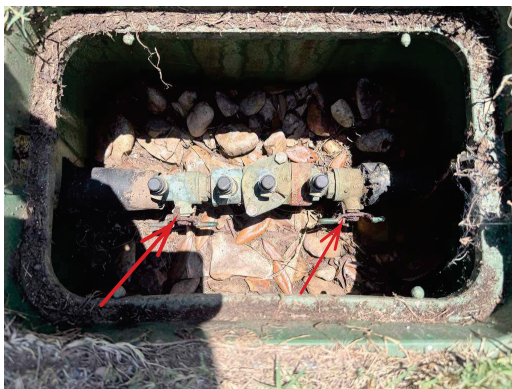
Comments: A manual function test was performed on this system. This system has 5 watering stations. The shut off handles for the backflow preventer valve are rusted on and are in need of repair. All other visible components were found to be in satisfactory condition at the time of the inspection.
