**499 STILL HOLLOW CRK, BUDA, TEXAS 78610**  
**SELLER LETTER TO BUYERS**

Inspection Report  
SITE HAWK Home Inspections, LLC  
Jared L. Beard  
TREC Lic. # 20361

499 Still Hollow Creek, Buda, TX 78610

Prepared For:  
Michael Reeves  
04-06-2026

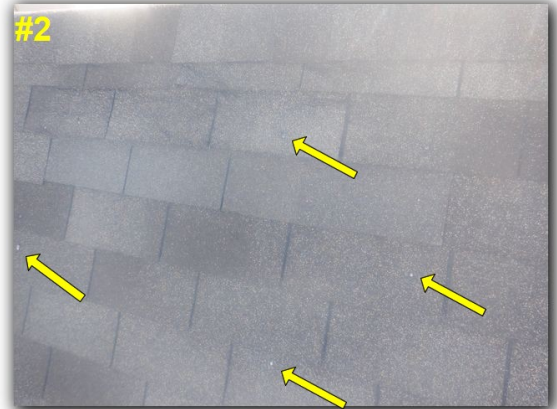
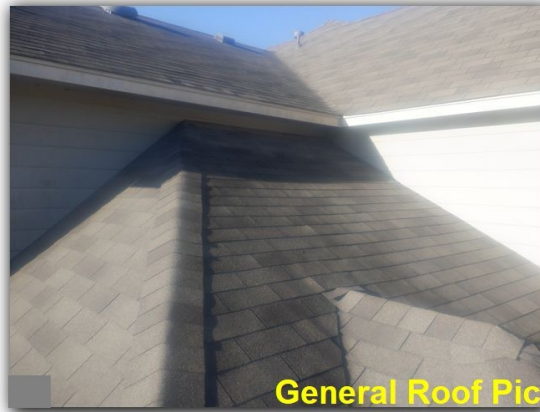
- Note - There is minor roof shingle granular loss evident on the roof shingles, which appears to be from normal wear.
- Nail heads are puncturing up through several of the roof shingles (see roof shingles at lower front and upper front of roof as example) **(see photo #1 below)**.
- There is damage to a few of the roof shingles at the upper back left side of roof (near ridge). There are several nails over the shingles at this areas (possibly to prevent shingle uplift here) **(see photo #2 below)**. The exposed nail heads should be sealed to better prevent water penetration.

Roof has been inspected and repairs have been made, singles replaced, etc.

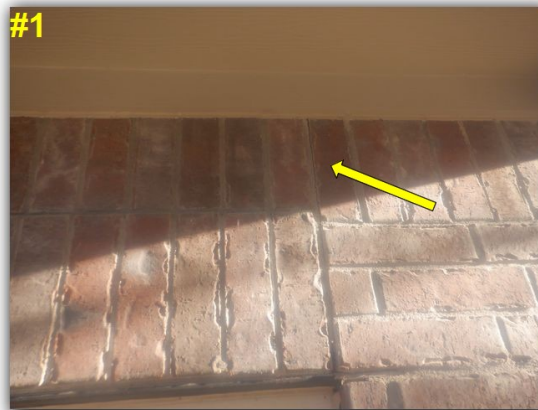
- There is hairline cracking in the mortar joints around the brick at one or more areas suggesting some minor settlement/movement has occurred (see at top left and top right corners of overhead garage door as example) **(see photo #1 below)**.

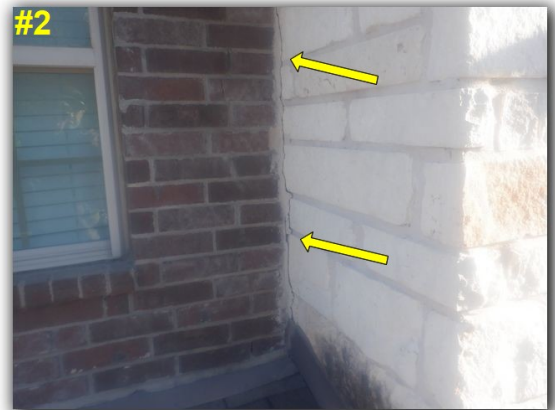
- Re-caulk/seal where siding trimwork meets brick (see at upper left side of home as example).
- Re-caulk/seal gap where brick and stone walls meet at upper front left of home and re-caulk/seal where stone and stucco walls meet at upper front of home **(see photo #2 below)**.

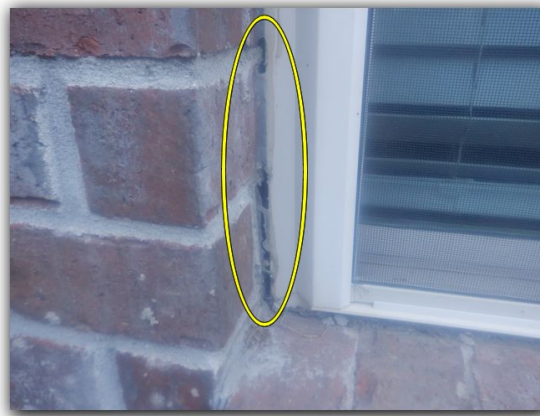
- Note - Screens have been removed from some of the windows. Some screens were found in the attic at time of inspection.
- Re-caulk/seal around exterior of windows and window trimwork where needed (see windows at left side and rear of home as example) **(see photo below)**.
- Some of the windows appears to have a blown seal and/or Low-E defects inside the glass panes (see windows in kitchen nook and living room as example).

All screens have been removed and cleaned and are stored in the attic near the HVAC unit

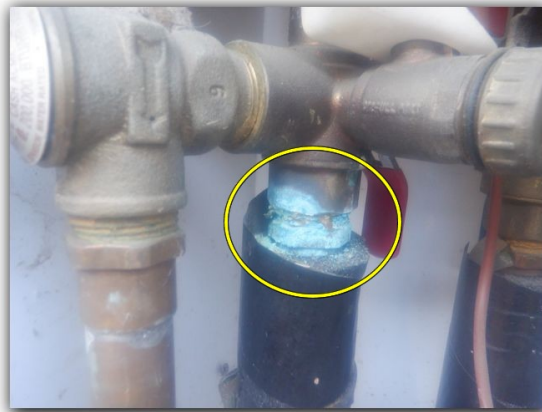
- There is corrosion on a water supply connection right under the tankless water heater at right side of home (**see photo below**). Note - This connection was dry at time of inspection.

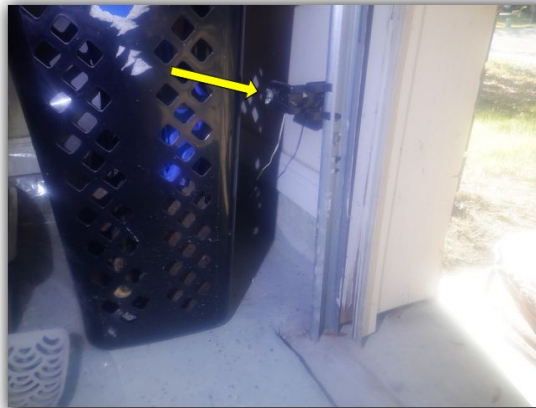
- The overhead garage door operator's auto-reverse safety sensors are currently installed too high up (**see photo below**). These sensors should not be installed higher than 6 inches above the garage floor for child safety.

**Sensor has been moved to the required 6 inch height**
