APPRAISAL OF REAL PROPERTY

20926 W Lakeshore Dr
E 91.55 FT OF LOT 13 LAKEWOOD ESTATES
Spicewood, TX 78669

06/13/2025

Uniform Residential Appraisal Report

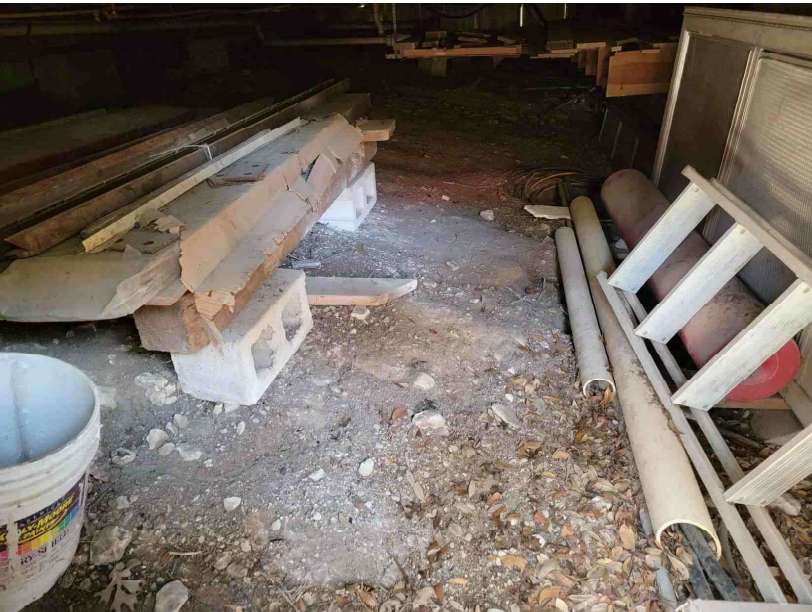
Subject Foundation

As noted previously, signs of settlement were noted throughout the interior and exterior of the subject improvements. The settlement, typical in the area, has been assumed to have cause only cosmetic damage and not to have compromised the structural integrity of the improvements. ***This report is made with the extraordinary assumption, the settlement noted is cosmetic in nature and has not compromised the structural integrity of the improvements.*** It should be noted the appraiser is not an expert in this field and a qualified foundation specialist is recommended to ascertain the extent of the settlement and/or any damage associated with such.
