**GREENBELT STRUCTURAL SERVICES**  
A DIVISION OF TAHI LLC

Client Name: Mark Biales  
Inspection Date/Time: 2/24/2025 at 1pm  
Property Address: 809 Mariposa Unit 1  
Austin , 78704

Assessment Type: REI 7-6

## PROPERTY INSPECTION REPORT FORM

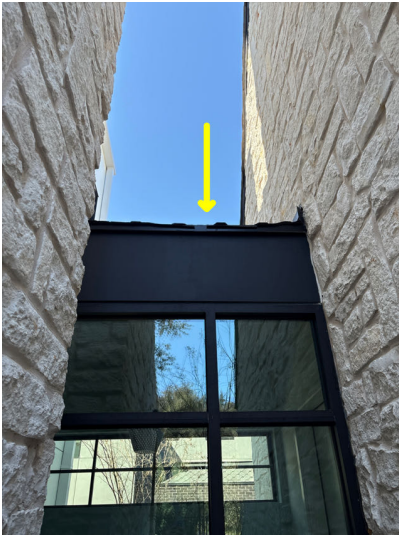
**Although gutters were installed on some sections of eaves, other sections had no gutters present. Gutters should be installed over areas with high foot-traffic or inadequate ground slope away from the foundation.**

No gutter / no eave

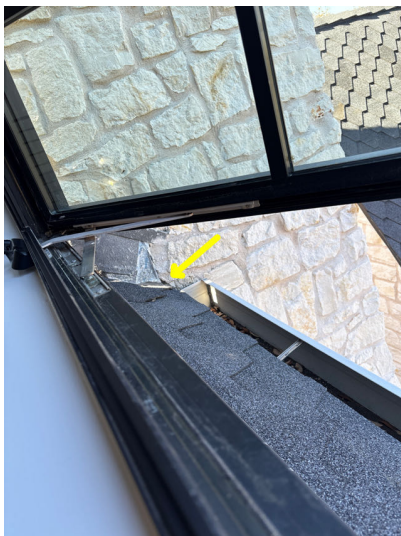
Kick-out flashing was missing in one or more area where a wall extends past a roof edge. This condition may allow premature deterioration of the exterior wall covering, and/or moisture penetration into the wall cavity. Kick-out flashing should be installed at the intersection of the wall and roof edge, to divert moisture away from wall materials.

**MISSING KICK-OUT FLASHING**  
-above chimney

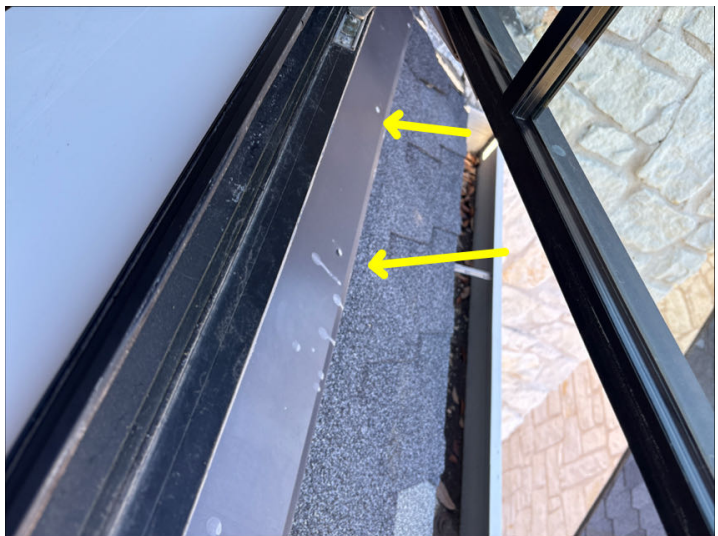
One or more fastener on the roof covering was not properly sealed. All fasteners should be properly sealed to prevent them from pulling up and rusting, including in areas such as: the ridges, around waste vents, and all roof covering penetrations.

**UNSEALED FASTENERS**  
-third floor below windows

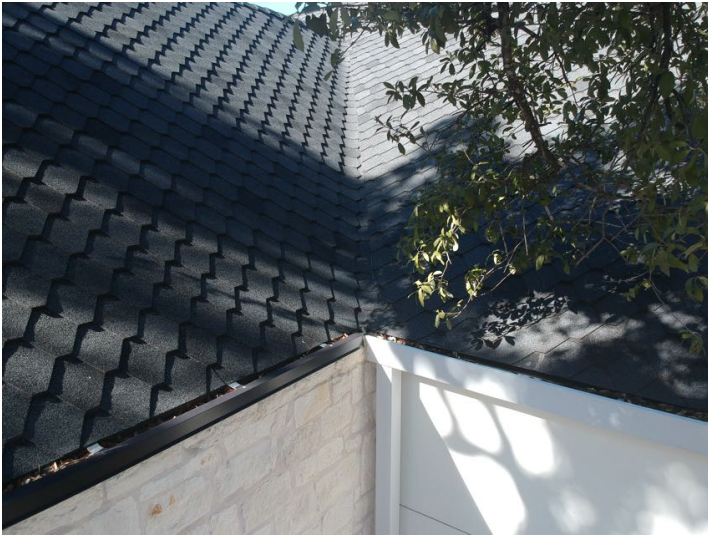
Tree limbs were overhanging/touching the roof structure. Branches that overhang or touch the roof increase the need for structural maintenance and monitoring. Tree limbs should be kept trimmed away from the structure, to prevent abrasion of the roof covering and potential leaking. Periodically monitoring and trimming the branches will reduce the likelihood of future damage. Ensure all tree debris is regularly cleared from the roof and/or rain gutters.

TREE IN CONTACT WITH SHINGLES

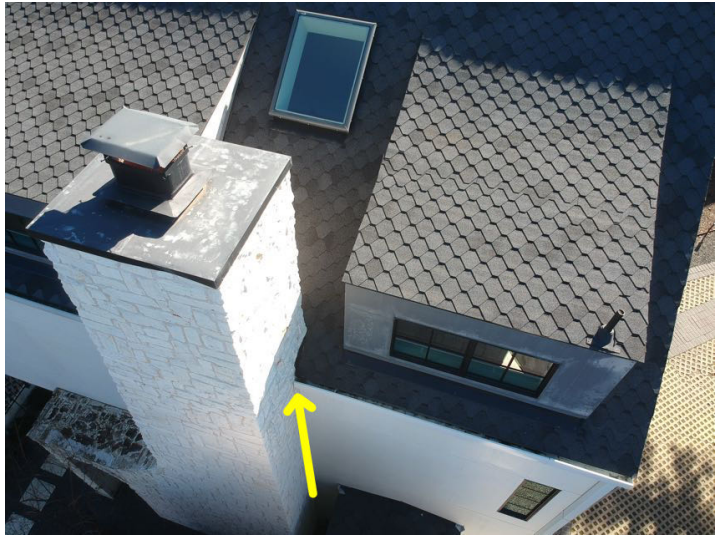
MISSING KICK-OUT FLASHING

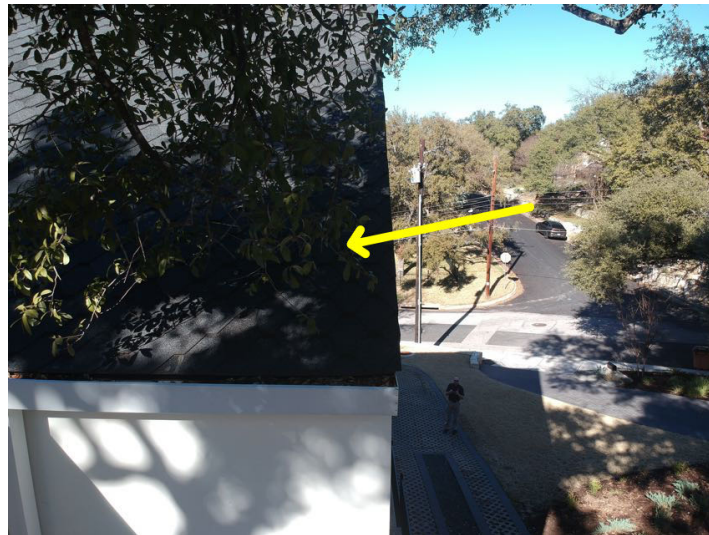
TREE CONTACT

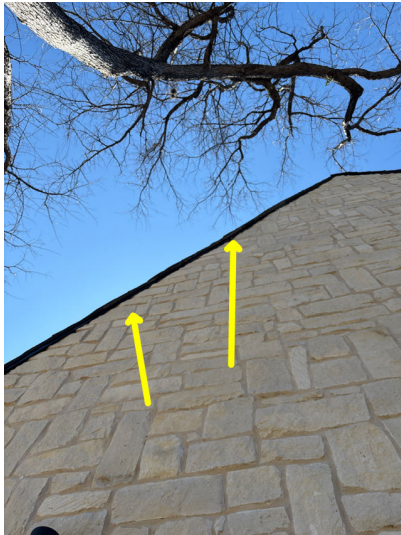
**Gaps/holes were observed at the soffit, which are potential pest/vermin entry points. Ensure all gaps and holes at soffits are covered/sealed, for improved protection against animal entry into the home.**

Gaps behind garage drip edge  
-weathered roof decking visible

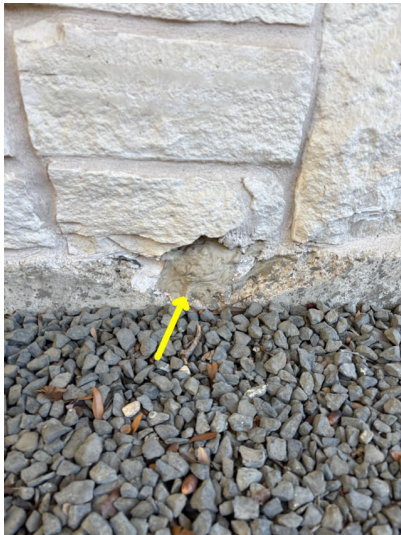
Previous repair near front door  
-consult owner as needed

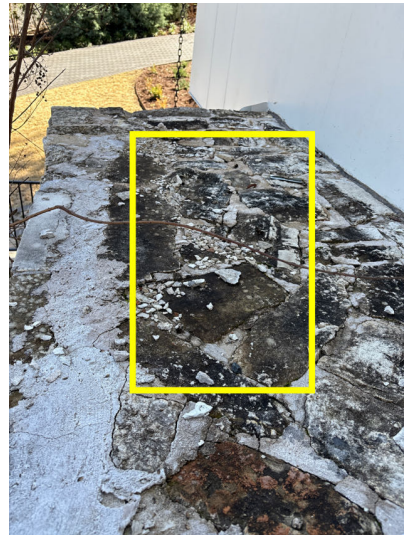
Gaps/cracks were observed in the mortar of siding materials on the home. Affected areas should be repaired/sealed to prevent insect & moisture intrusion.

LOOSE MORTAR JOINTS  
-entry arch

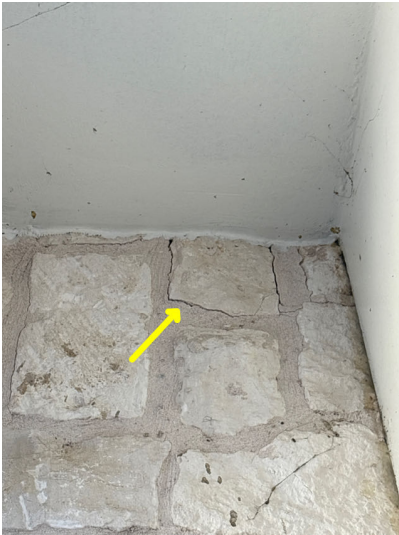
Mortar cracks/separation

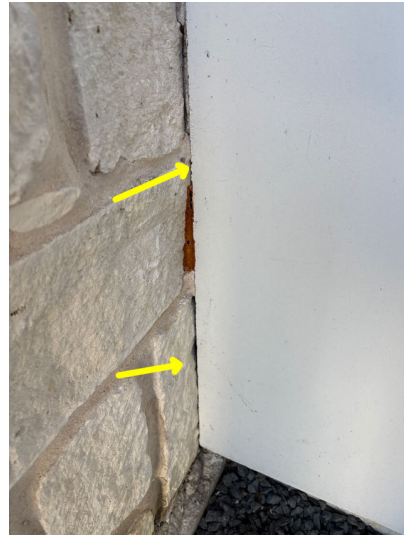
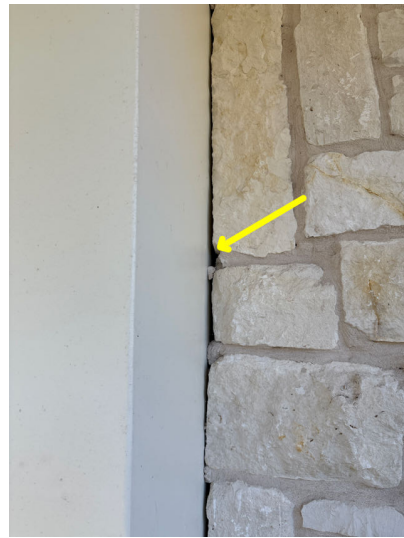
Gaps were observed between sections of siding. In this condition, the wall is more susceptible to moisture and insect intrusion. Affected areas should be sealed, to provide improved protection of the wall.

GAPS BETWEEN SIDING

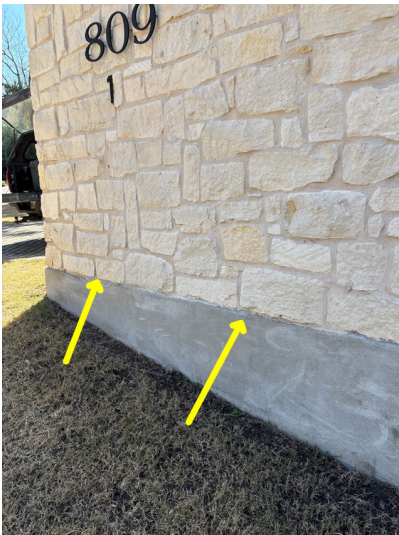
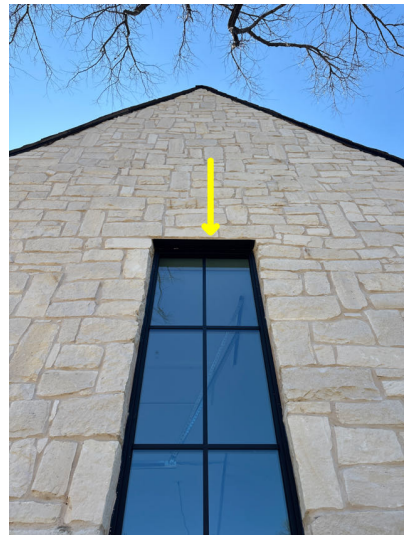
Weep holes were not present on one or more brick wall. Weep holes should be present and spaced every 33", to allow ventilating air into the wall cavity and ensure dry conditions within.

MISSING WEEP HOLES  
-garage

Missing weep holes  
-garage lintel

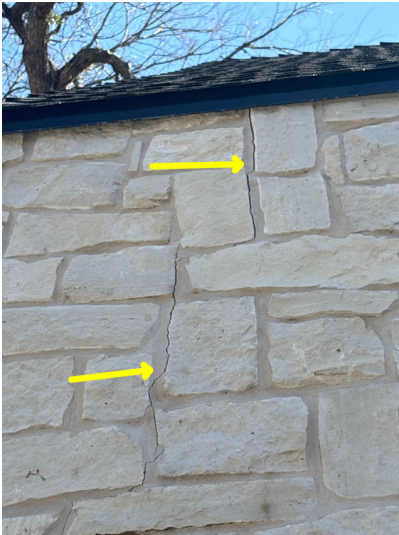
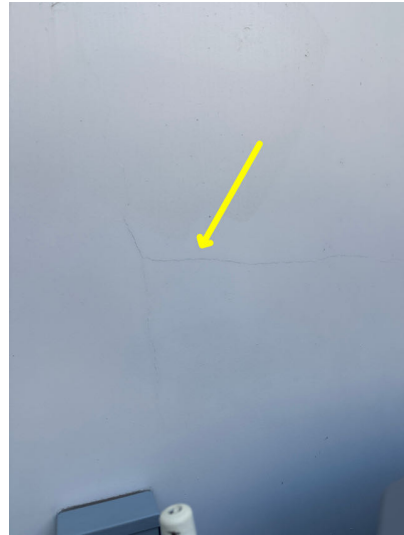
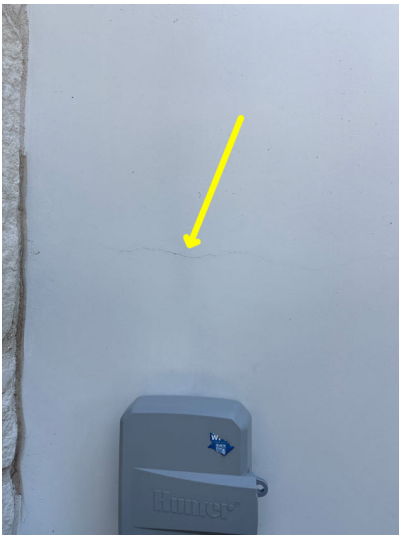
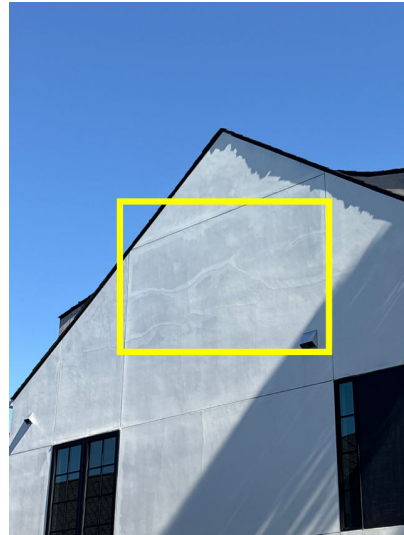
Exterior wall cracks that appeared to be the result of structural settlement and shifting were observed in one or more area of the structure. Affected areas appeared to be mainly cosmetic in nature, and not indicative of significant structural issues (cracks less than 1/8" in width are common). Ensure affected areas are periodically monitored and maintained/sealed. If wall cracks increase in size and/or number, then it may be warranted to have the condition further evaluated by a trade professional.

EXTERIOR SETTLEMENT CRACKS

Stucco cracks

Large stucco cracks

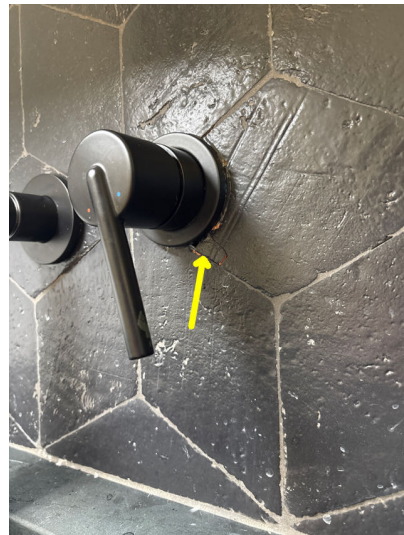
Tile behind bar faucet was damaged. Repair recommended to prevent condition from worsening.

Damaged tile  
-bar area

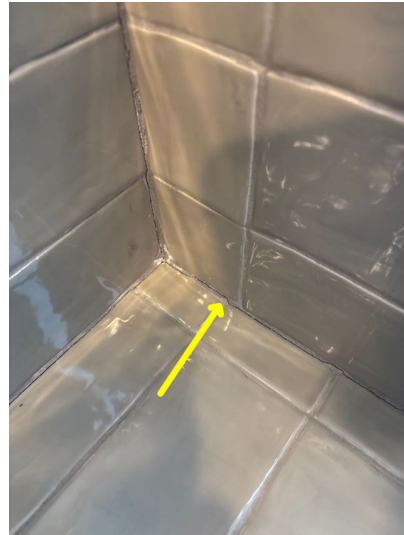
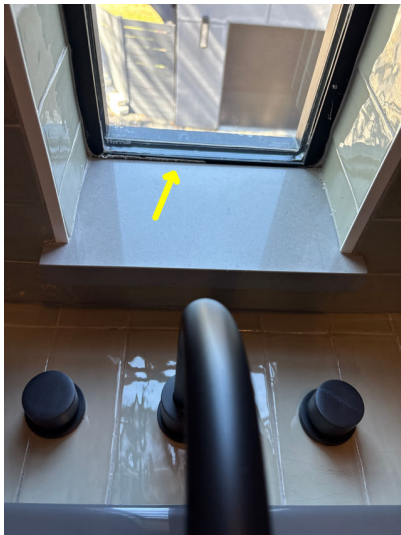
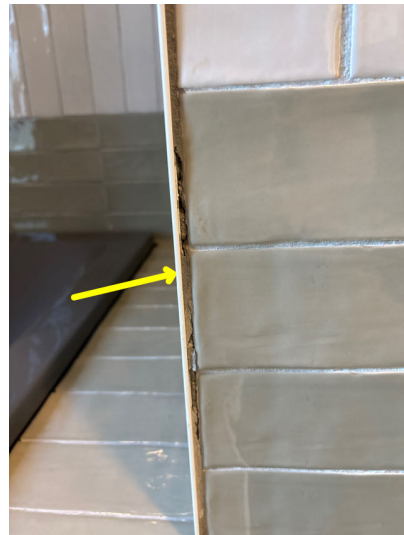
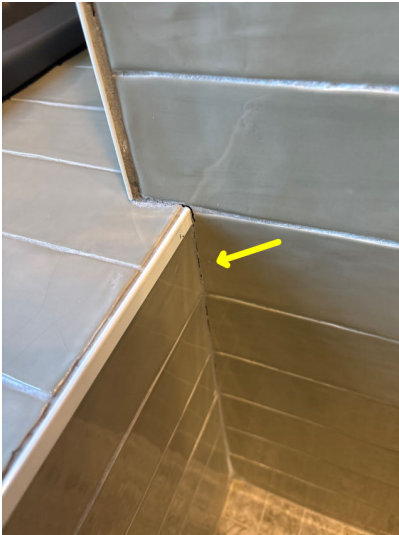
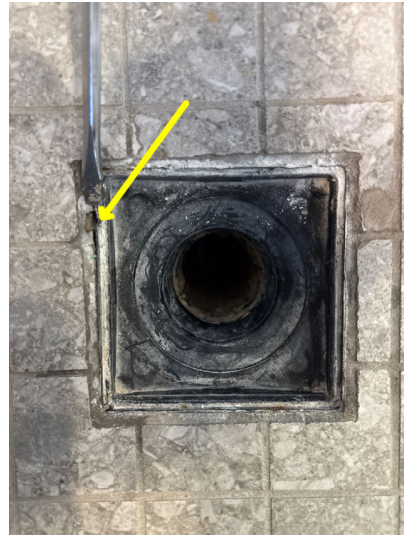
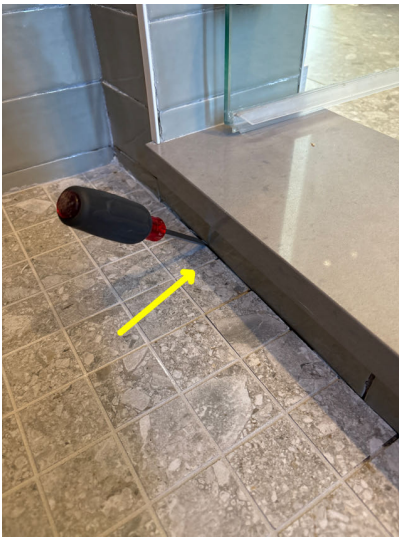
Gaps/cracks were observed on the wall near a water fixture. All gaps/cracks in the vicinity of water should be repaired/sealed, to prevent areas of concealed fouling and damage to surrounding surfaces.

GAPS / CRACKS AT TUB

GAPS / CRACKS AT SHOWER

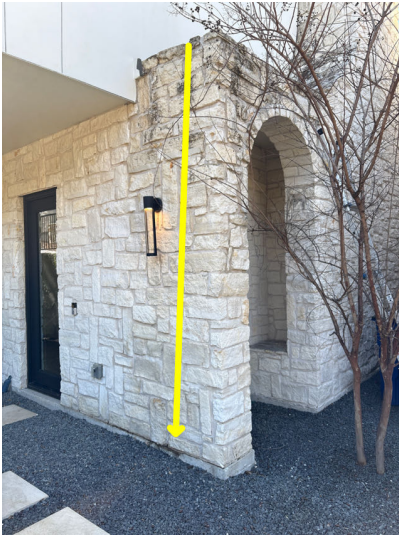
Water penetrating through horizontal masonry and coming out of weep holes

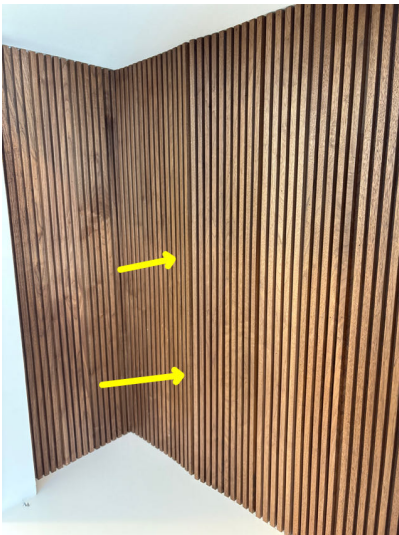
Accent wall is loose

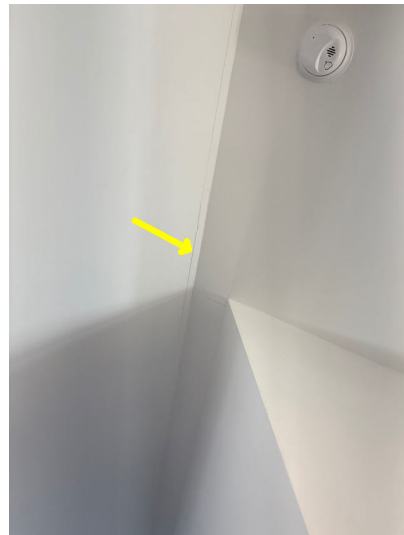
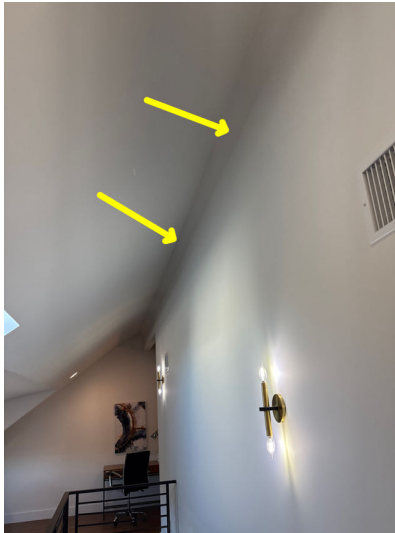
INTERIOR SETTLEMENT CRACKS

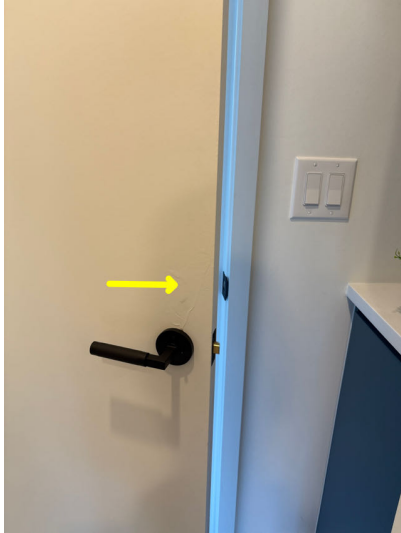
A misaligned latch was observed on one or more door, which should be adjusted to allow for proper functionality and security.

Latch issue  
-Jack and Jill bath

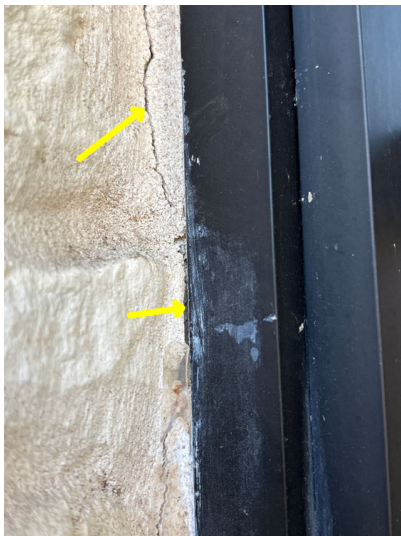
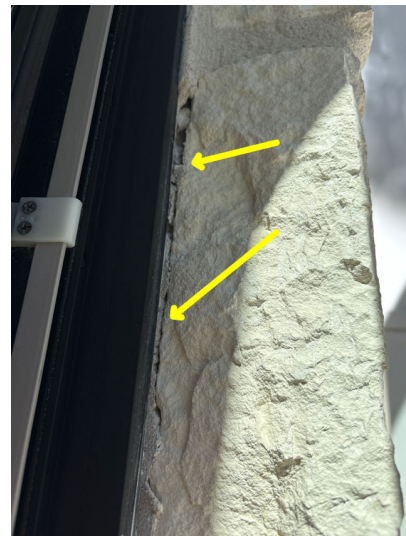
Sealant gaps were present at materials around interior and/or exterior windows. Affected areas should be properly repaired/sealed to prevent damage to adjacent materials, and to prevent potential moisture penetration into the wall cavity.

GAPS / CRACKS AT WINDOW SEALANT  
-first floor, multiple windows

GAPS / CRACKS AT WINDOW SEALANT  
-primary bedroom

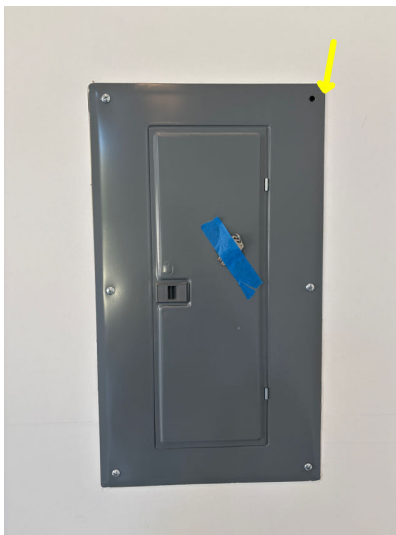
One or more electrical panel cover was missing screws, which should be replaced to ensure electrical components are properly protected.

Missing fastener

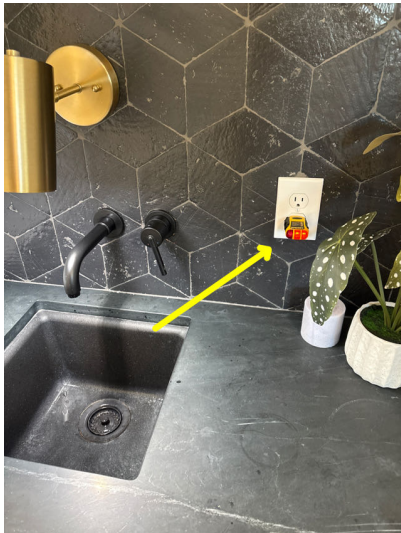
**Ground Fault Circuit Interrupter (GFCI) outlet protection was missing at one or more required location. GFCI protection should be installed for outlets**

GFCI PROTECTION MISSING  
-bar

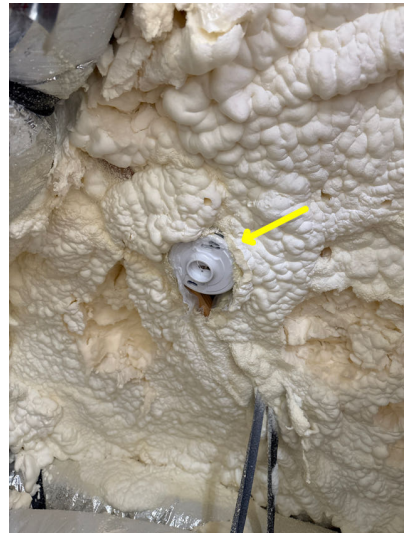
One or more lightbulb was missing, which should be replaced.

ATTIC LIGHT BULB IS MISSING

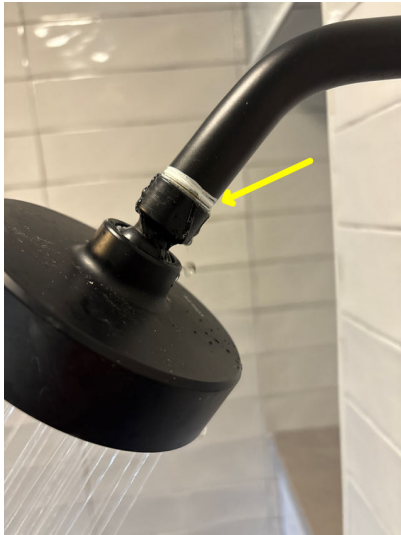
**A drip/leak was observed at one or more water fixture. This indicates an issue with the mixing valve and/or other faucet hardware. A plumber should further assess and address this issue as needed, to restore proper functionality to the fixture and prevent damage/wasting water.**

Shower head leak

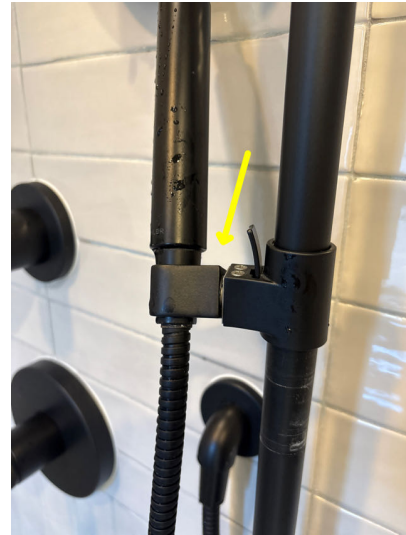
Damaged wand holder

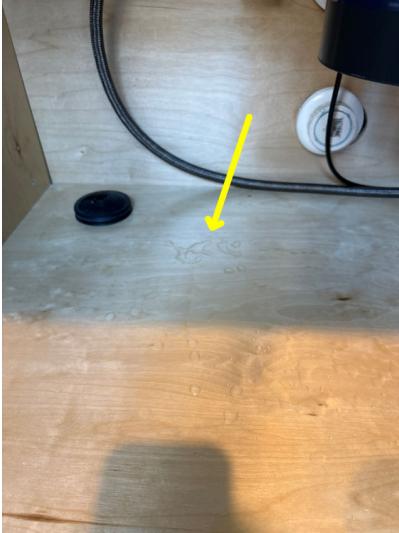
Water in cabinet below kitchen sink

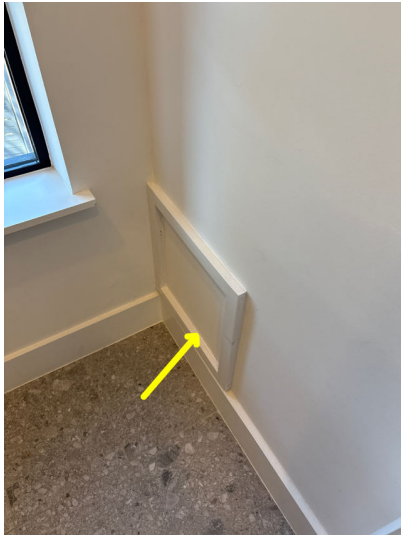
Tub access panel is painted to the wall. Not removed for inspection

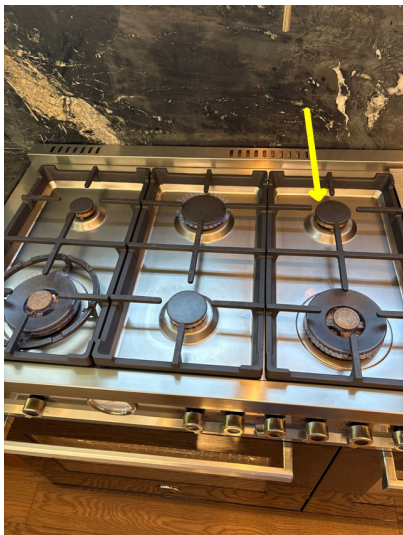
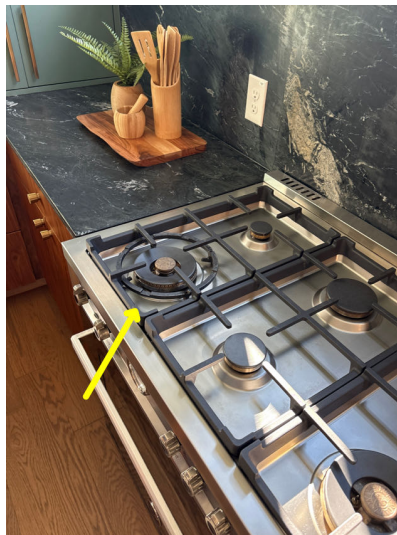
The cook top had one or more burner that did not respond to controls. For gas-powered cook tops, this is often caused by faulty ignition elements or issues with the gas valves/supply or burner cap. In electric-powered cook tops, a non-functioning burner may indicate an issue with the control board or heating element. The unit should be repaired/replaced, to allow for proper functionality.

UNRESPONSIVE BURNER

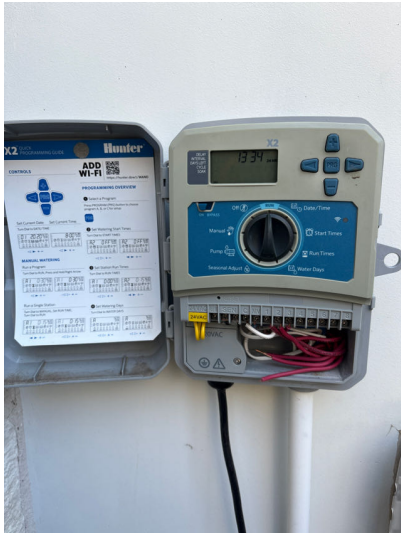
No clear map or other indicator of sprinkler zones/head locations was observed at the control panel. Consider adding a sprinkler map for ease of use and service/inspection.

Zone map not present
