FINAL "AS-BUILT" SURVEY

Inspection Report
SITE HAWK Home Inspections, LLC
Jared L. Beard
TREC Lic. # 20361

3712 Werner Ave, Austin, TX 78722

Prepared For:
Alicia & Summer Ross
04-06-2026

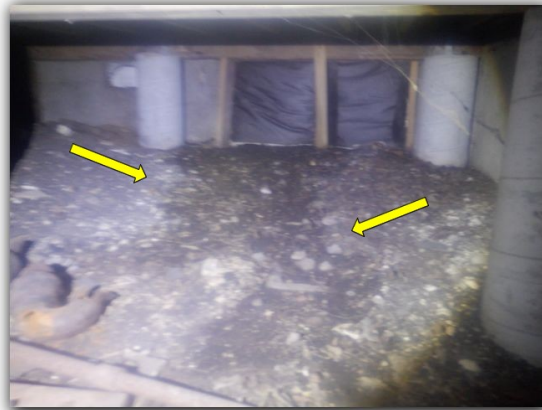
- Advisory - Large trees were present within 10 feet of the foundation (see at right side of home as example). Trees and large bushes can adversely affect the performance of the foundation due to root uplifting and hydration. Note - There was no observed visual damage found due to tree roots at time of inspection.
- There is evidence of minor water intrusion into the crawlspace near the right rear corner of the home (ground was damp) (**see photo below**). Improvements to grading and/or drainage may better prevent this from occurring.

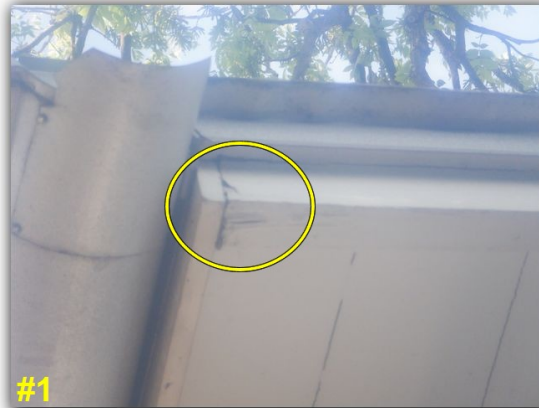
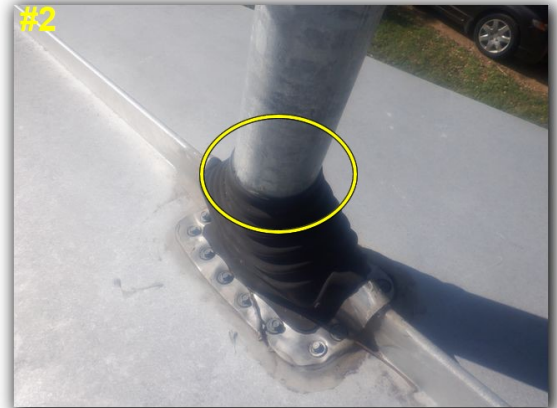
- There is some minor rot on the roof fascia boards at one or more areas (see at front right corner of home and at left side of front patio as example) **(see photo #1 below)**. Repair as needed and re-caulk/seal and paint to better protect from further damage.
- Recommend re-painting the exposed roof framing members and exposed underside of the roof decking where needed to better protect from damage (see at outer front and rear of home as example). Note - There is a section at the rear that is completely missing paint as well.
- Some of the roof penetrations need to be re-caulked/sealed to better prevent water from penetrating into the home (see roof boot jack around electrical mast as example) **(see photo #2 below)**.

Soffit has been repaired and repainted, all roof penetrations have been recaulked

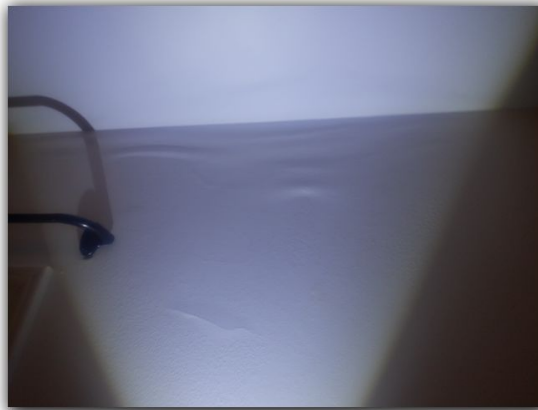
- The drywall is a bit wavy at the top of the wall and ceiling above the front windows of the living room (**see photo below**). Note - This area tested dry at time of inspection with a moisture meter and thermal imaging.

Wavy drywall is due to a roof leak in 2016. The roof was repaired but the drywall was not

The drywall above the bay window is "wavy" due to a roof leak in 2016 (prior to us owning the home). The roof was repaired but the drywall was not.

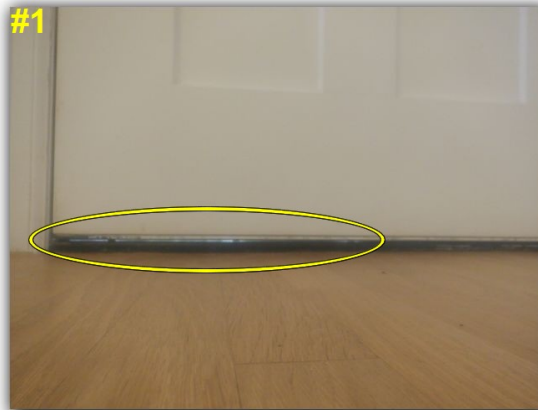
Front door weather stripping has been repaired.

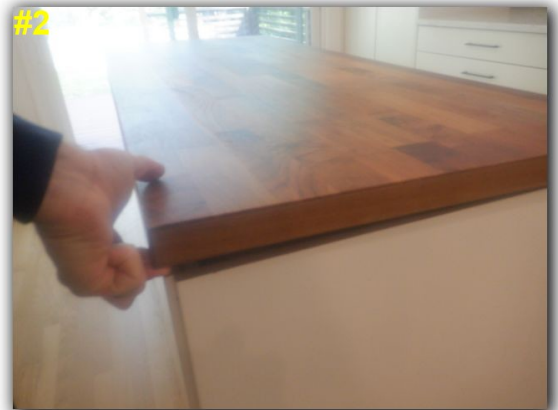
Kitchen island countertop has been repaired.

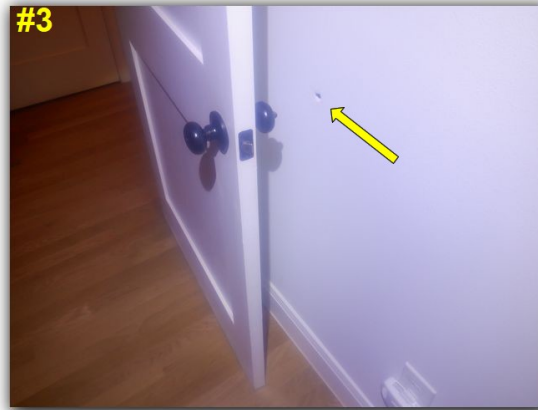
Middle bedroom doorstop has been added

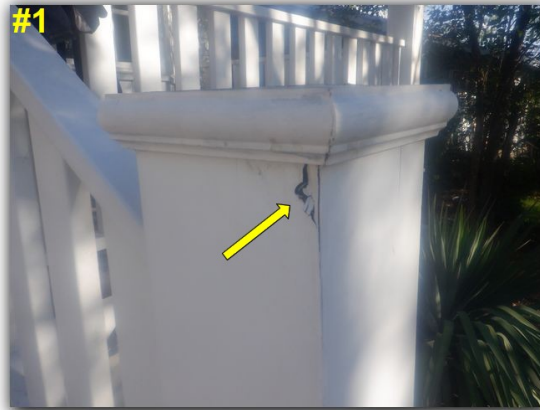
- There is minor rot near the top of the right side support post for the front patio stairs (**see photo #1 below**). Patch and repaint as needed.
- The front patio stairs do not currently have a grippable handrail in place. By today's building safety standards, a grippable handrail is added for safety.
- Finish is fading and there is some weathering/splitting occurring on the rear patio deck planks (**see photo #2 below**). Recommend sanding down the boards and adding a new protective coat to the deck planks and deck guardrails to better protect from weathering and damage.
- A few of the fence pickets have been cut at their bottom at right side of property (where tree stump is located).

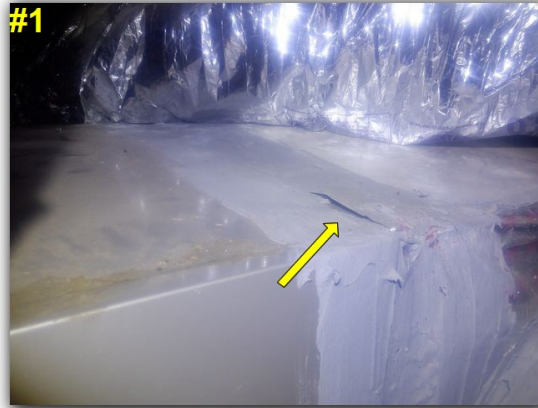
- One of the HVAC ducts needs to be re-sealed where it connects to the plenum, at back right side of unit in the attic (see photo #2 below). Re-seal duct with mastic to better limit air leakage.
