Inspection Report
SITE HAWK Home Inspections, LLC
Jared L. Beard
TREC Lic. # 20361

11408 Bruce Jenner, Austin, TX 78748

Prepared For:
Chris Folmar
05-15-2026

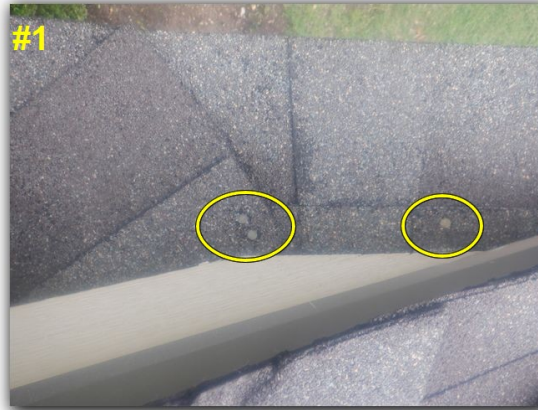
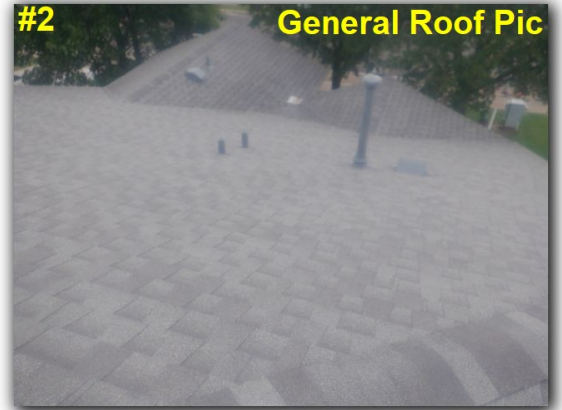
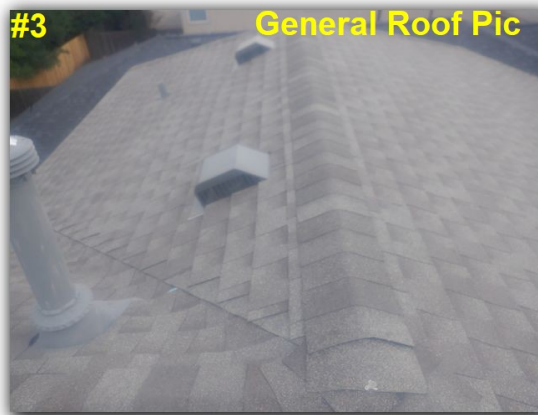
- Exposed nails were present at one or more areas on the roof (see at lower outer front left corner of roof as example) (see photo #1 below). These nails should be caulked/sealed to better prevent deterioration or possible leaks.

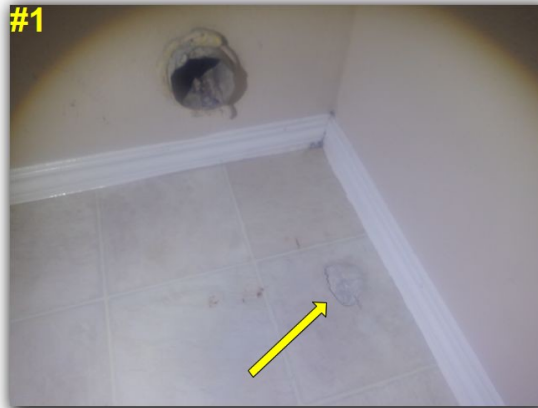
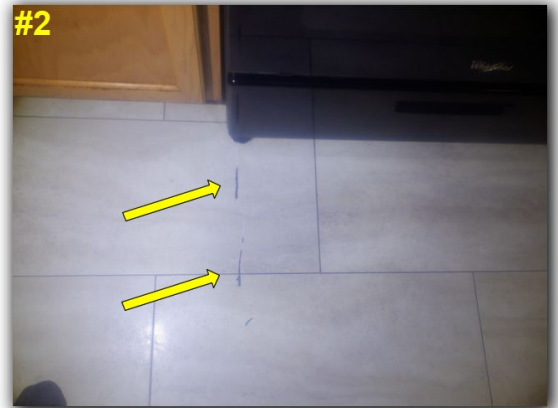
- There is a small tear to the vinyl flooring in the laundry room (**see photo #1 below**). Note - This area will most likely be covered by dryer.
- There is minor damage to the flooring in the kitchen in front of the oven (appears to be from sliding the unit in and out) (**see photo #2 below**).
- Ceiling cracks were observed at one or more areas (see ceiling at top of stairs as example). This type of cracking is generally considered to be cosmetic.
- Carpeting is loose at some areas (see in living room, hallway outside primary bedroom, and in 2nd floor rear bedroom as example).

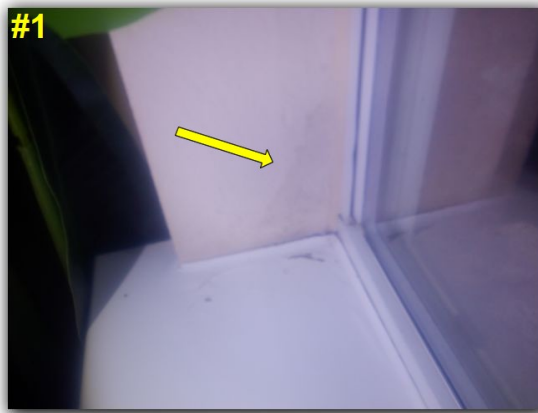
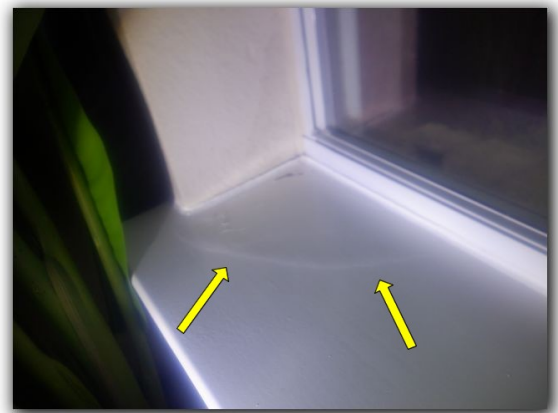
- There is minor evidence of water/moisture penetration at the bottom edges of drywall at a few of the window sills (see window sills in living room, primary bathroom, and 2nd floor rear bedroom as example) (**see photo #1 below**). Note - This is typically from water condensation rolling down the window frames (all areas tested dry with a moisture meter at time of inspection).

- There is evidence of previous water or moisture damage to interior window sill in living room and kitchen nook (**see photo #2 below**). Note - These areas tested dry at time of inspection.

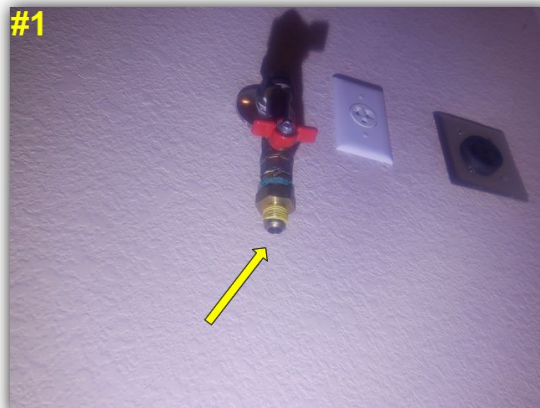
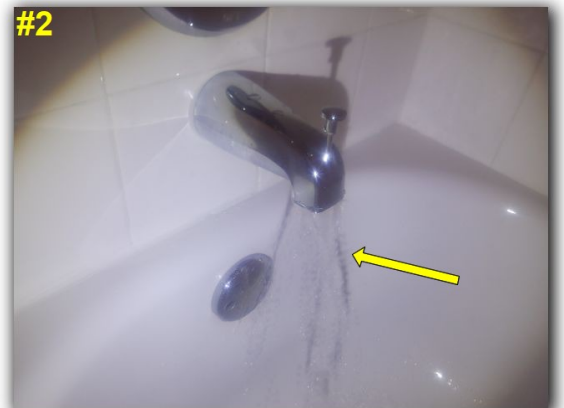
- Anti-siphon device missing from exterior hose bibs (*note - this is a newer requirement and will not be present on all homes*). Recommend adding this device to hose bibs to better prevent water back-flow.
- Toilet paper holder needs repair in the 1st floor powder room.
- Advisory - The gas supply valve for the clothes dryer needs to be capped off when not in use for safety (**See Photo #1 below**).
- The primary bathroom shower pan's weep holes have been caulked/sealed over. These holes should be opened back up to better allow trapped water/moisture an escape route.
- The 2nd floor hall bathroom tub/shower diverter was not diverting all water from the tub faucet to the shower head when activated (**See Photo #2 below**). Needs repair or replacement.

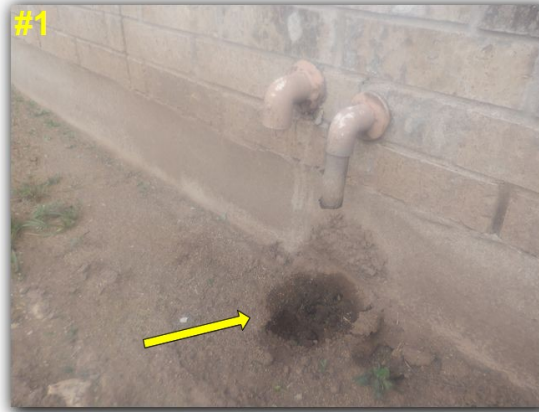
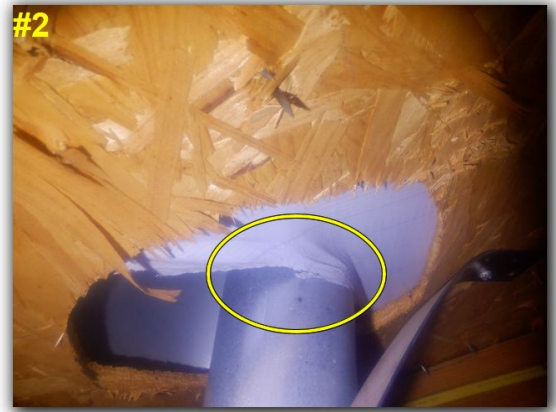
(see photo #1 below). Also, the valve did not appear to be flushing water when tested at the unit. This is typically an indication that the temp/pressure valve needs replacement (**Plumber to evaluate and repair as needed**).

- The water heater flue is in contact with flammable material (roof underlayment) in the walk-out attic where it penetrates the roof (see photo #2 below). There needs to be a gap made between the flue and flammable material for fire safety.
