SUPER INSPECTOR

2025 TREC REI 7-6 SUPER INSPECTOR\*

18420 Blush Rose Rd  
Pflugerville, TX 78660

# PROPERTY INSPECTION REPORT FORM

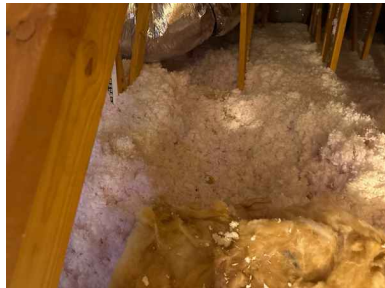
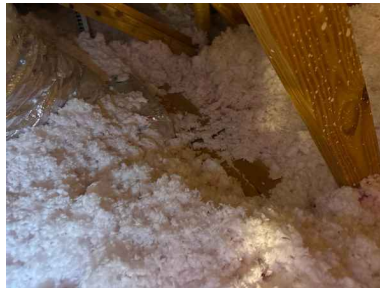
The blown attic insulation is compressed. Compressing blown insulation can significantly reduce the R Value. Additional insulation may need to be installed in those areas to help prevent heat infiltration from the attic.

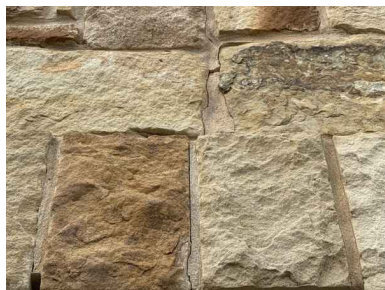
Above Garage

## 2: Algae was observed on the exterior veneer

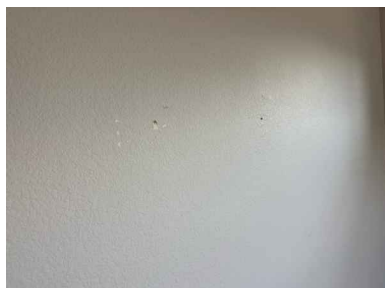
Northeast Bedroom

There is mechanical damage to the interior walls/trim. Repair as necessary.

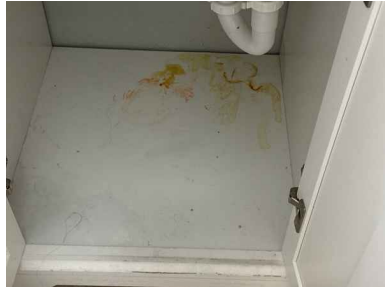
Hallway Bathroom

Stains were observed under a sink. This could be due to spills of stored items, or it may indicate a past or present leak in that area. The cabinetry can be repaired as desired.

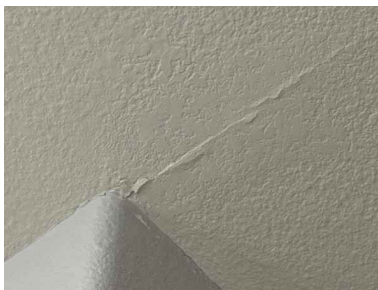
2nd Floor Northwest Bedroom

### 1: Ceiling Common Cracks

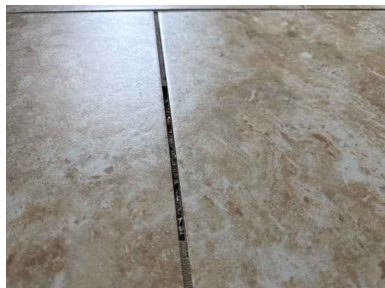
Master Bathroom

Cracked, separated grout was observed in the floor grout. This could be related to poor tile installation, foundation settling, or loose sub-flooring. Further evaluation and repair are advised.

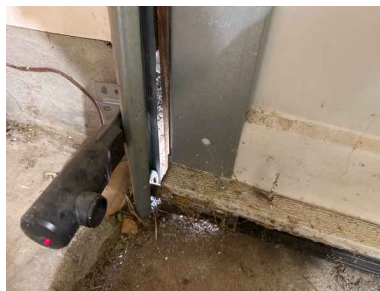
Openings were observed around the garage door casing. These areas should be sealed to help prevent pest intrusion.

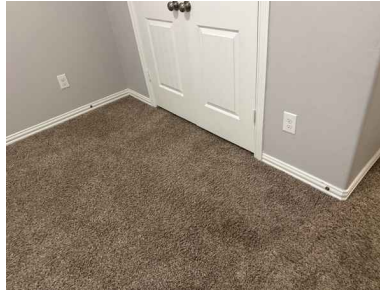
Northwest Bedroom

**3: Missing / non-functioning doorstops**

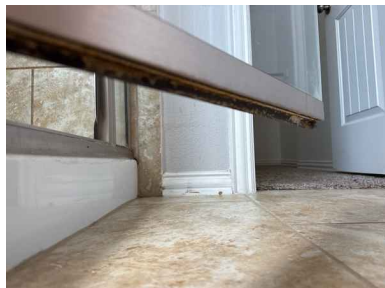
The weatherstripping on the shower door is damaged. Repair or replace as necessary to prevent water from escaping the shower enclosure.

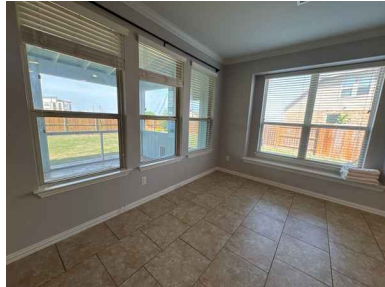
Due to the windows being dirty, it is difficult to inspect the integrity of the thermal seals. It is recommended that the windows be cleaned and inspected due to the age.

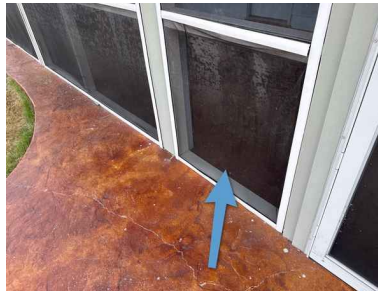
Back

### 1: Window Screens Damaged

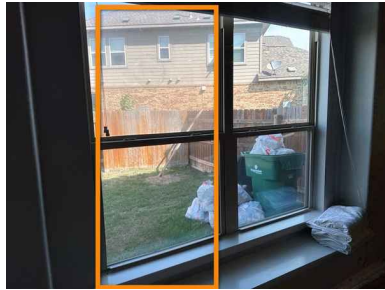
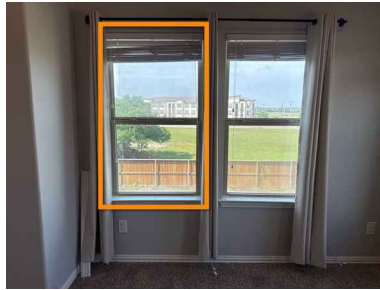
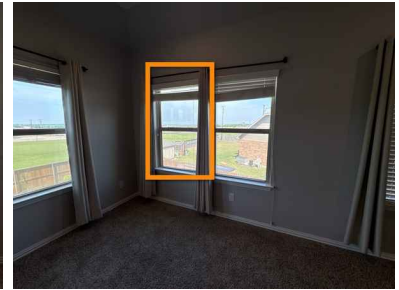
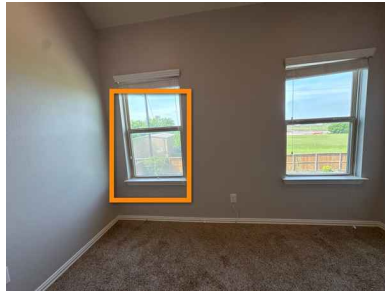
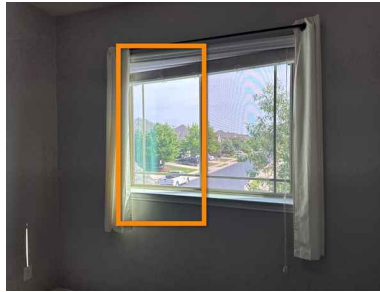
There are window(s) with visible evidence of a broken thermal window seal. This causes condensation to form between the window panes leaving water deposits that cause discoloration between the panes over time. This does not materially affect the performance of the windows. All of the windows should be checked by a window specialist to determine if there are any more broken seals to properly estimate repair costs.

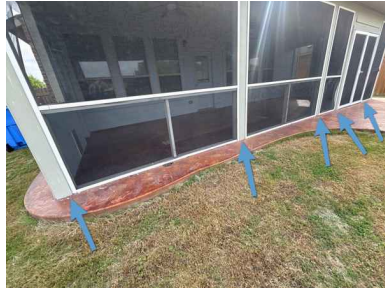
The porch cover posts are in contact with the ground or porch slab. This can allow moisture to wick into the wood post causing damage over time. For posts in contact with concrete slabs, special "Chairs" are

commonly used to separate the posts from the slab and prevent moisture damage. Repair as necessary.

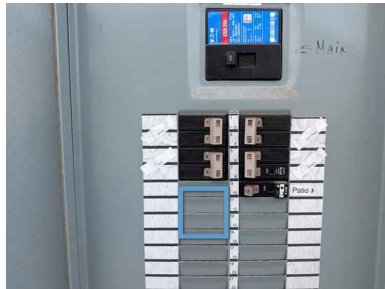
There is missing or improperly installed Surge protection devices in required locations in the home. It is recommended that surge protection be installed in accordance with current building code.

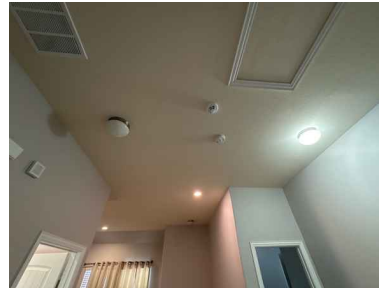
2nd Floor

There are missing carbon monoxide alarms in the home. Carbon monoxide alarms should be installed in accordance with current standards, as follows: 2009 International Residential Code R315.2.1 New construction. Carbon monoxide alarms shall be provided in dwelling units when either or both of the following conditions exist: 1.) **The dwelling unit contains a fuel - fired appliance.** 2.) The dwelling unit has an **attached garage with an opening that communicates with the dwelling unit.** R315.3 Location. Carbon

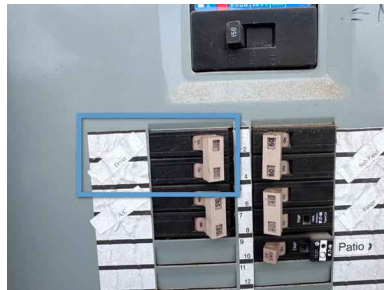
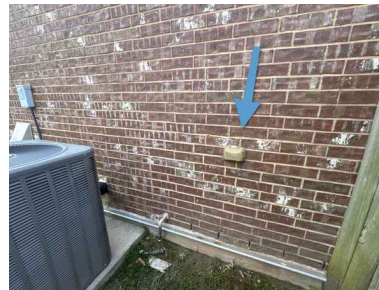
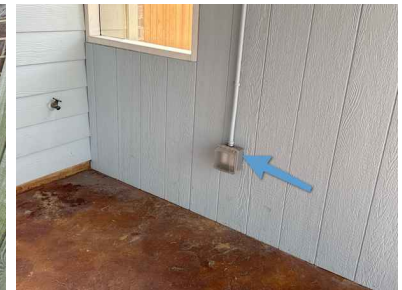
There is missing GFCI protection in required locations of the home. It is recommended that GFCIs protection be installed in accordance with current building code. Also, the 2020 NEC updated the requirements for GFCI protection to include some 250v circuits, as well as the existing 125v circuits. This house may pre-date these standards.

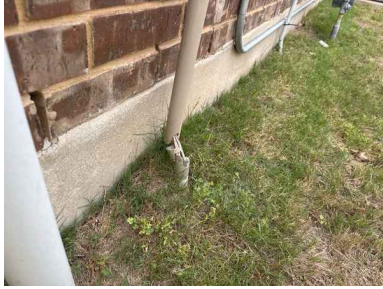
Right/Front

The conduit protecting the sprinkler system wiring is damaged. Repair is recommended to protect exposed wires from accidental damage.

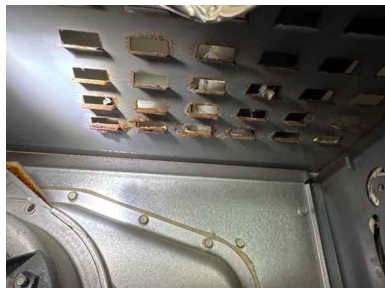
Corrosion / rust was observed inside the furnace housing. This could be the result of improper venting, excessive moisture, or leaks from the flue pipe. Recommend a HVAC contractor evaluate and repair.

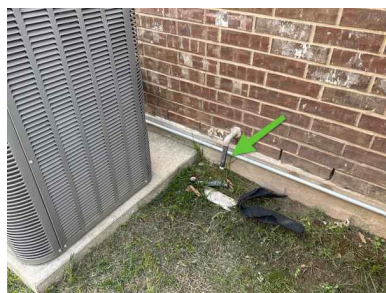
If the condensate drain line could not be located this may indicate the drain line is not properly terminated. Locating the drain line is advised.

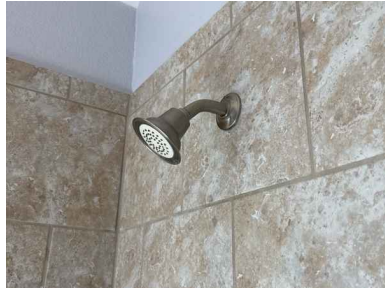
Master Bathroom

The bathtub and/or shower faucet are not properly sealed to the wall. The escutcheons and faucet should be sealed to the wall to prevent moisture penetration in those areas.

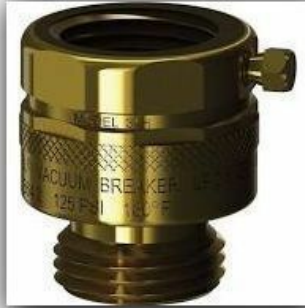
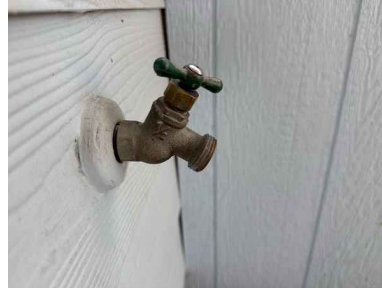
The exterior faucets are not freeze protected or protected from back-siphoning. It is recommended that all exterior plumbing is freeze protected and exterior faucets have an approved anti-siphon device installed to protect the home and public drinking water supply.

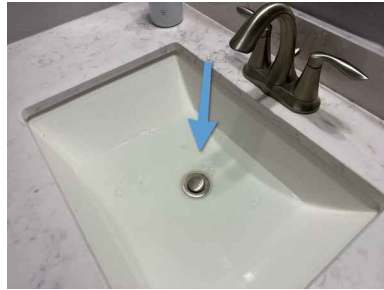
Half Bathroom

Drains drained slowly when tested. This may indicate a local blockage or a more extensive problem. Further evaluation and/or repair by a licensed plumber is advised.

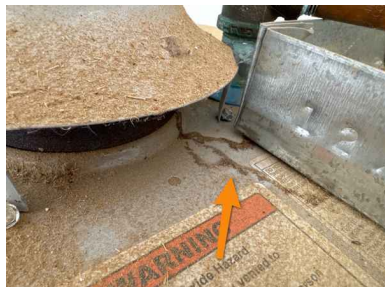
The water heater flue vent appears to be back drafting at the top of the unit. This could be due to improper flue installation and/or missing combustion air. This may allow carbon monoxide gases to enter this location. Further evaluation of the flue vent and repairs as recommended.

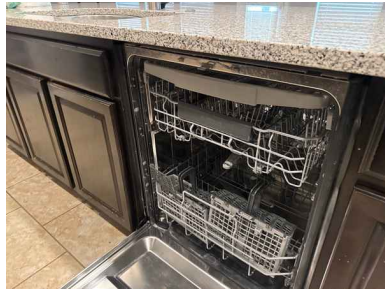
The dishwasher is not secured to the cabinet. The unit should be secured to the cabinet to prevent tipping.

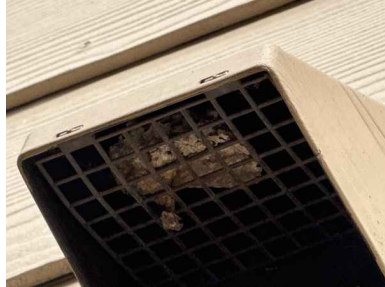
Left

There appears to be a wasp nest in the mechanical exhaust vent. Due to this the air flow may be obstructed. The wasp nest should be removed to ensure proper air flow.

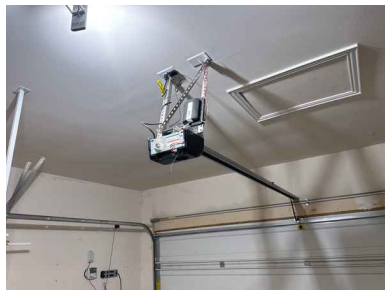
The garage door did not appear to operate at the time of the inspection. Further evaluation by an overhead door specialist is advised.

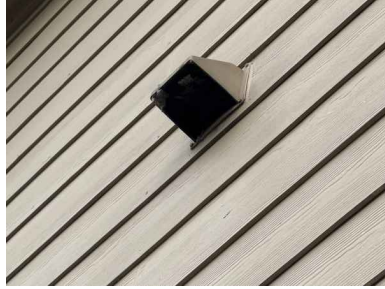
Left

Lint accumulation was observed in the dryer vent cover. This may indicate the vent and/or cover need to be cleaned and screen removed. Lint accumulations can obstruct air flow and reduce dryer performance. Additionally, dryer vent obstructions are a fire hazard. It is recommend the vent be cleaned to ensure proper performance.

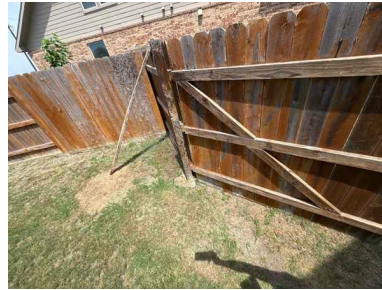
Zone 6

There are sprinkler heads spraying onto the fence. This can result in damage to the fence over time. The heads should be properly adjusted to direct spray away from the fence.
