Barfield Home Inspection Services

PROPERTY INSPECTION REPORT FORM

Concerning: 11602 Sterlinghill Dr Austin , TX 78758

Inspection Date: 12-1-22

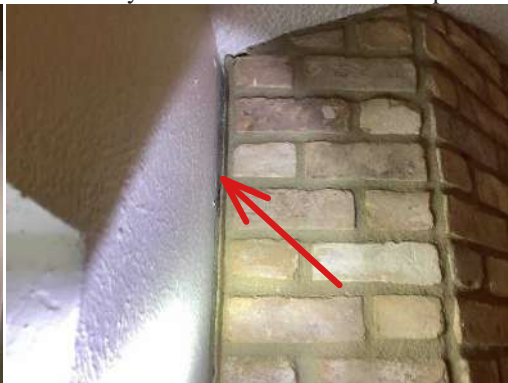
Comments: The interior walls have been recently painted.
 There is a hole in the sheet rock at the kitchen area under sink cabinet.
 The masonry fireplace hearth is separated at the left side sheet rock seam.
 The inspection of the interior walls of the garage area was limited due to stored items and wall coverings.
 There are holes in the wall material at the rear garage wall, near washing machine connection.
 There is a break in the sheet rock at the rear W corner breakfast nook area corner seam.
 There is deterioration of the toe kick plate at the kitchen cabinet.
 All other visible components were found to be in satisfactory condition at the time of inspection.

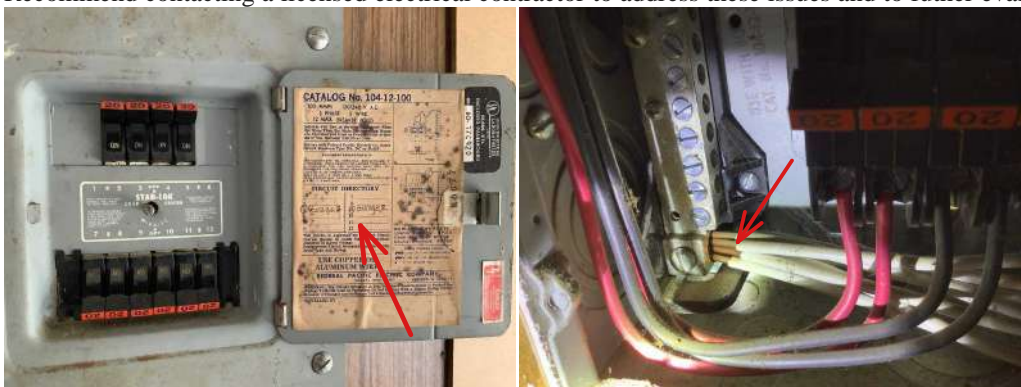
There are aluminum service feed wiring installed in the sub panel without the anti oxidant paste installed at the terminal points and bus bar connections.

Recommend contacting a licensed electrical contractor to address these issues and to further evaluate.

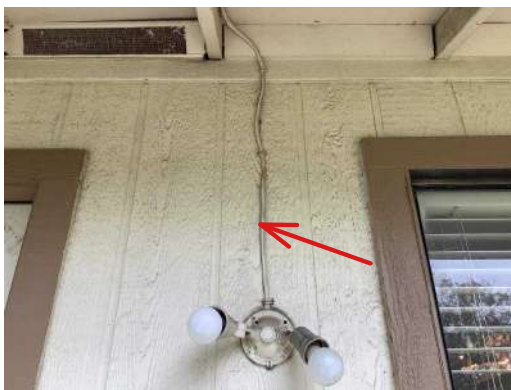
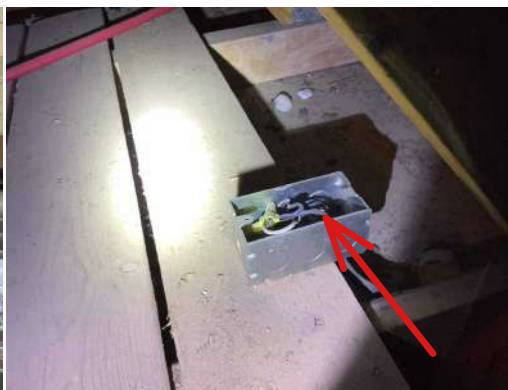
There are branch circuit wire connections at the attic area that are not secured properly in a covered junction box.

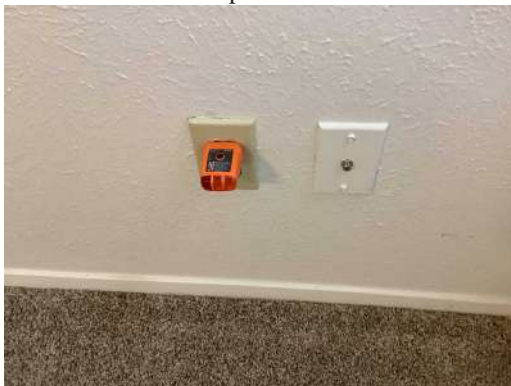
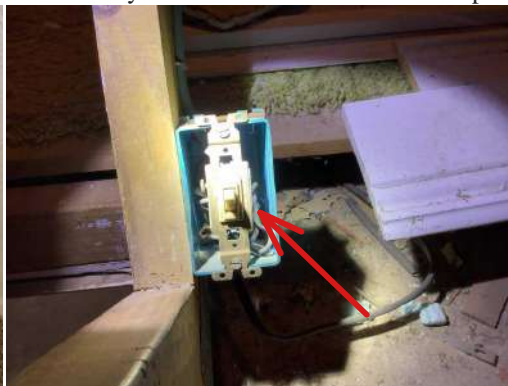
Comments: The upper socket at the rear W corner master bedroom wall outlet did not function when tested. This outlet may be switched on at the light switch, however the switch did not appear to function for powering the outlet.

There is a missing light switch plate at the attic area.

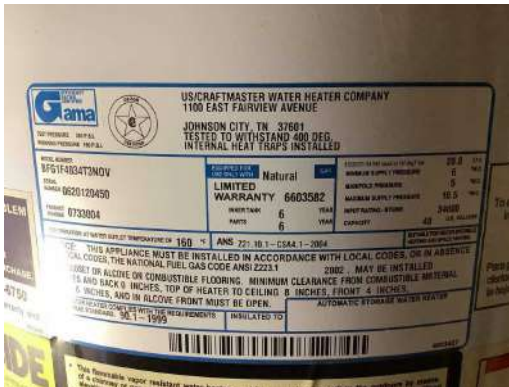
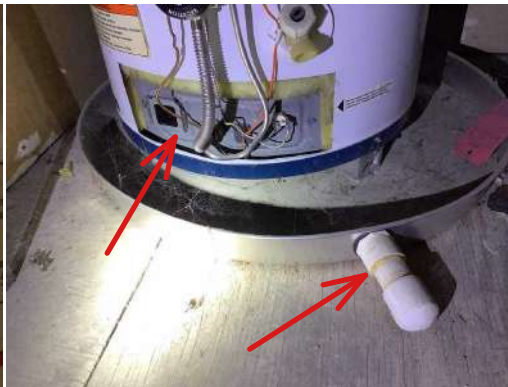
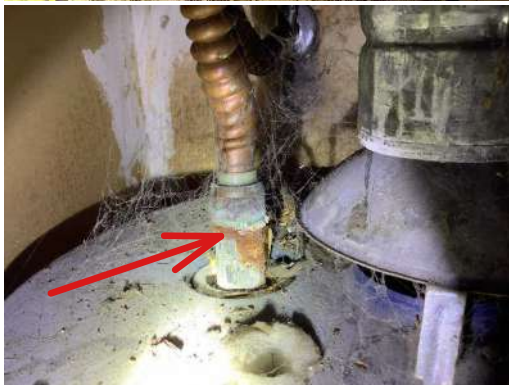
There is corrosion and/or signs of intermittent leak at the plumbing inlet lines at the top of the water heater unit.

Recommend having the water heater unit serviced and further evaluated by a licensed plumbing contractor.

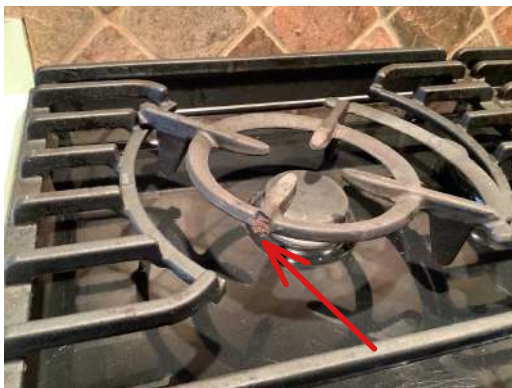
Comments: The rear left range burner grate is damaged.

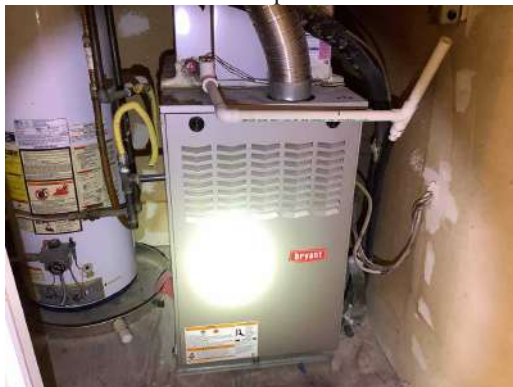
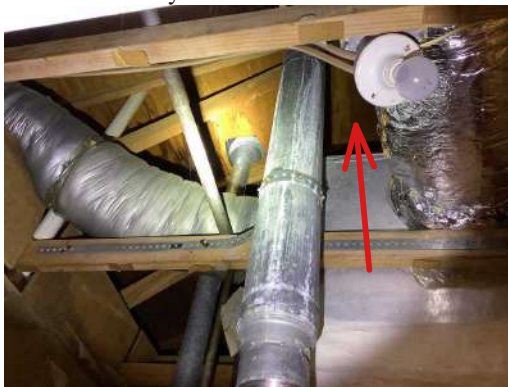
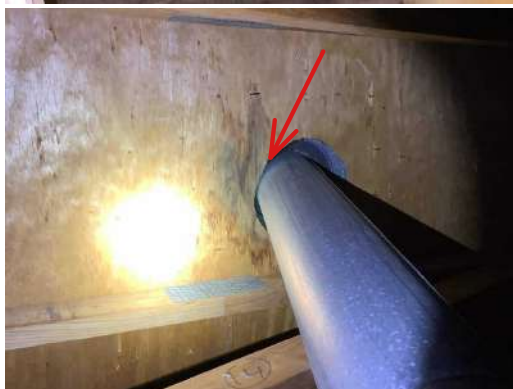
The flue pipe for the furnace at the roof penetration does not have the required 1 clearance from combustible materials.

It is recommended that a firewall ceiling be installed at the HVAC closet in the hallway for proper firewall protection from the attic to the living space.

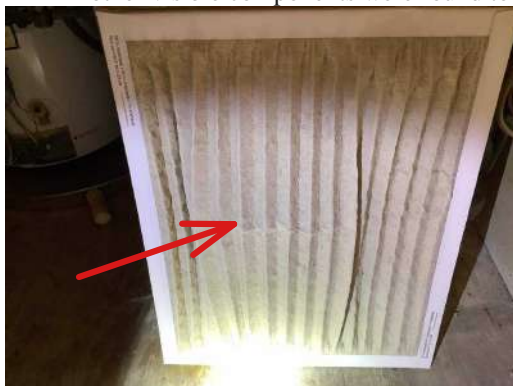
- C. Duct Systems, Chases, and Vents The return air filter at the unit in the hallway closet is dirty / clogged and should be replaced.
The return ducts lines appear to be dirty at the inside walls.
Recommend having a licensed repair contractor clean and and further evaluate the duct lines.
All other visible components were found to be in satisfactory condition at the time of inspection.

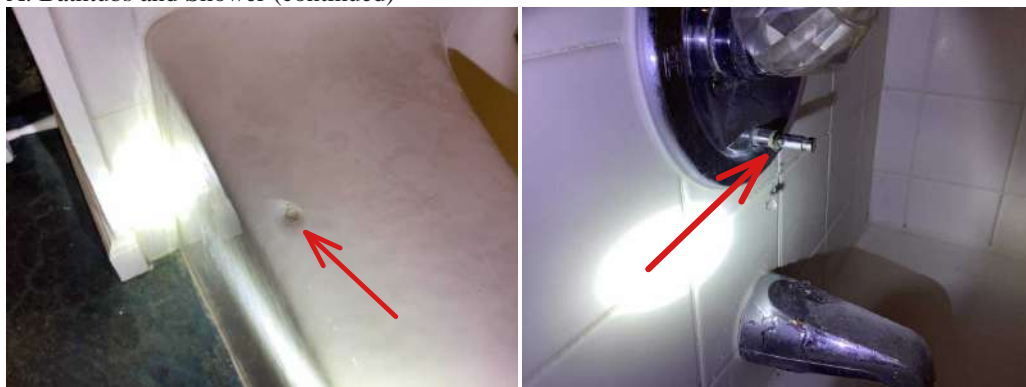
A. Bathtubs and Shower There is damage to the finish at the hallway bathroom tub.

The shower diverter stem for the hallway bathroom tub faucet leaks when tub faucet is in use.

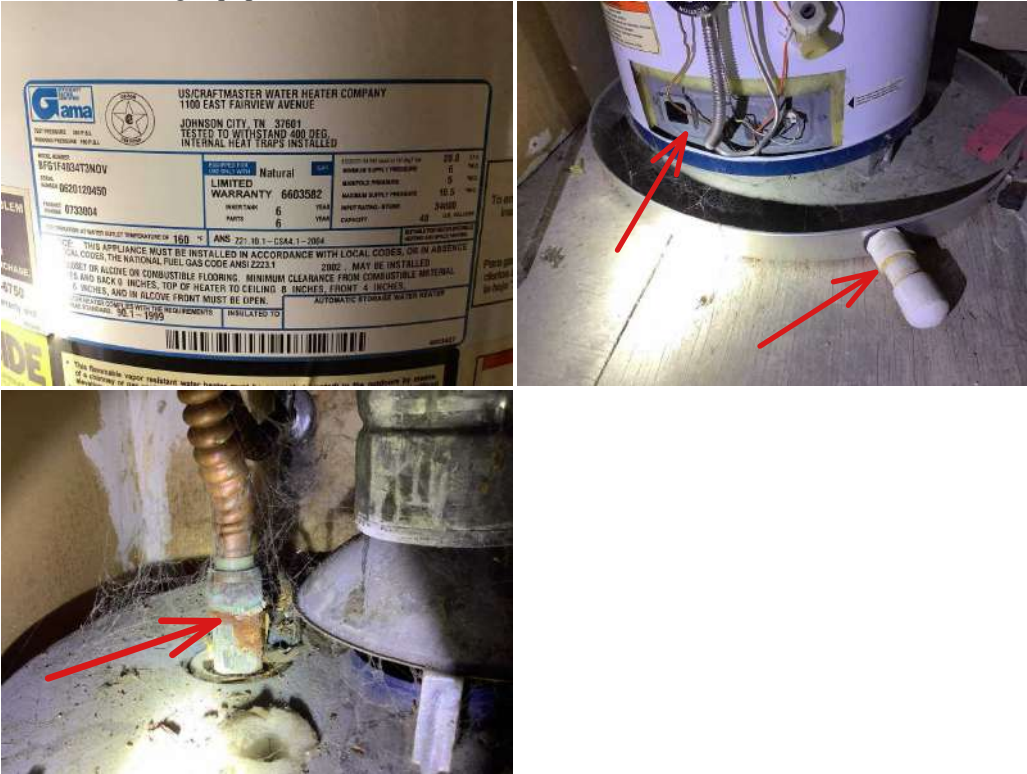
C. Water Heating Equipment The water heater burner heat shield is missing.

There is corrosion and/or signs of intermittent leak at the plumbing inlet lines at the top of the water heater unit.

It is recommended that the drain pan under the water heater be installed with a 1 inch drain run to the exterior to prevent water damage in the case of a leak.

It is recommended that the hot and cold water lines at the top of the water heater be insulated.

Recommend having the water heater unit serviced and further evaluated by a licensed plumbing contractor.

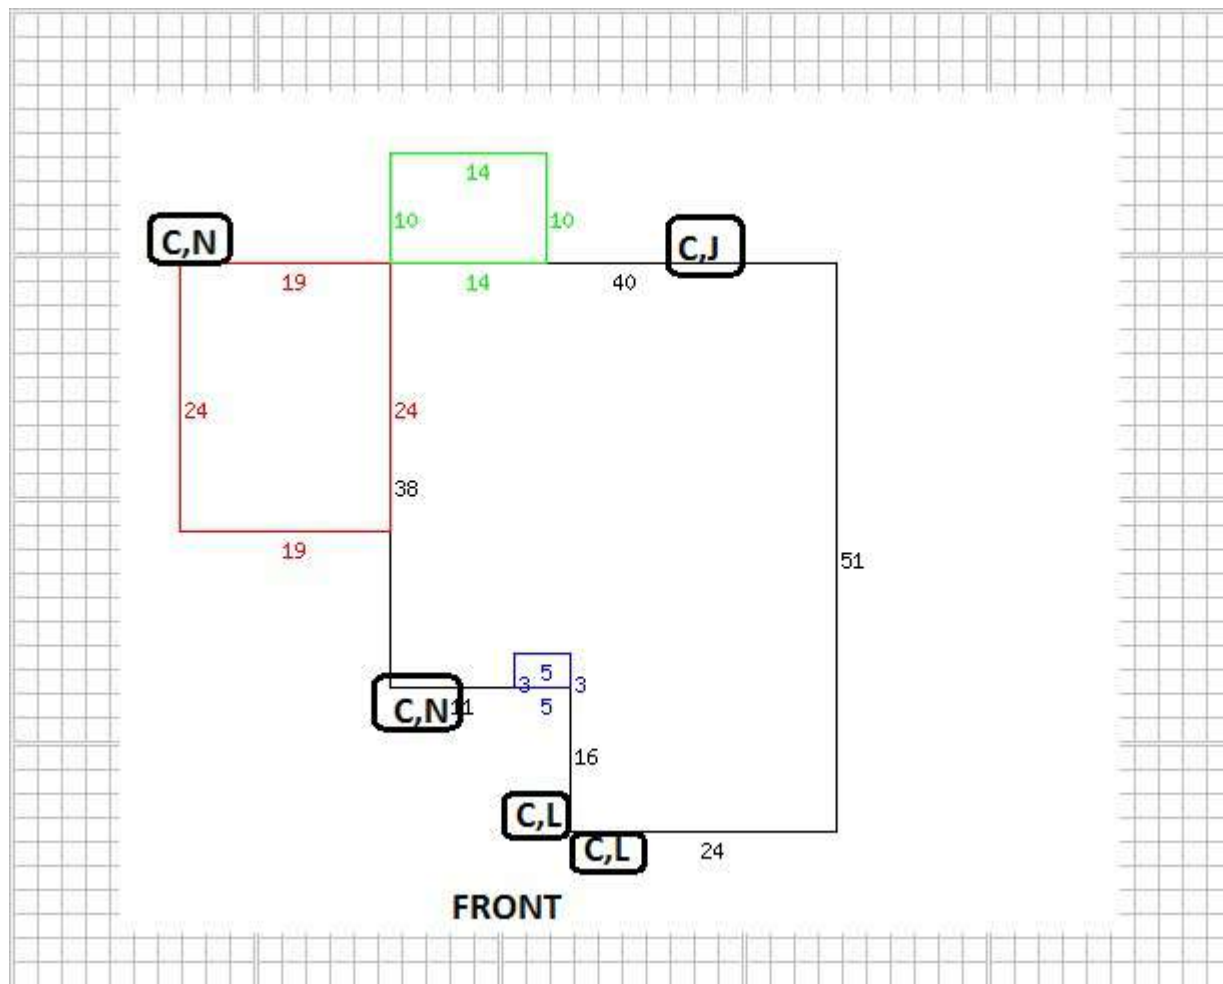
Diagram of Structure(s) Inspected

Additional Comments No visible infestation was found at the time of inspection under the conditions allowed, although there are conducive conditions favorable for termite infestation present. Recommend annual inspections.
