**Barfield Home Inspection Services**  
**1100 Rutherford Dr**  
**Driftwood, TX 78619**  
**(512) 350-0123**

## PROPERTY INSPECTION REPORT FORM

Concerning: 6905 Estana Ln Austin, TX 78739

Inspection Date: 07/27/2026

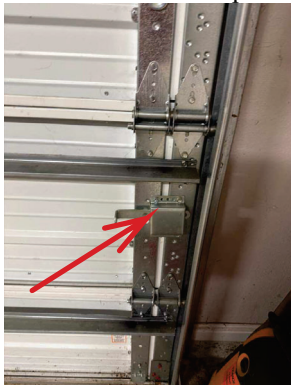
Comments: The garage door lock should be removed or disabled when there is a door opener unit installed.  
All other visible components were found to be in satisfactory condition at the time of the inspection

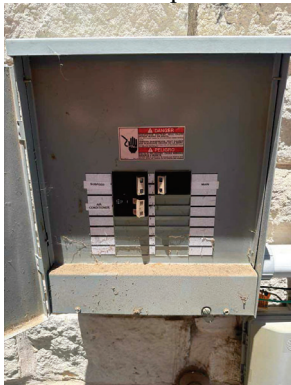
Comments: The main panel is located at the SE corner and is supplied with a 125amp main disconnect. All visible components were found to be in satisfactory condition at the time of the inspection.

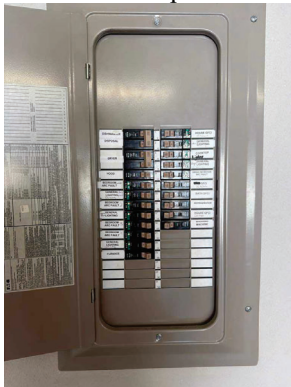
Comments: The sub panel is located at the interior wall of the garage. All visible components were found to be in satisfactory condition at the time of the inspection.

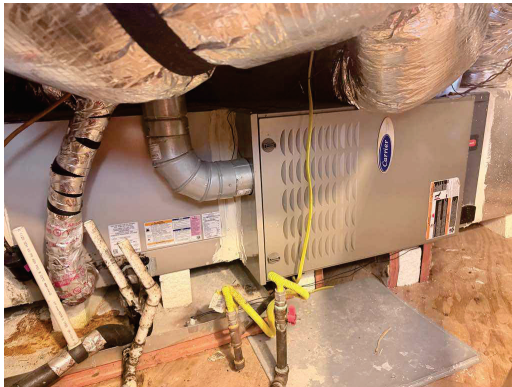
Comments: The heating equipment for this structure is a Carrier model gas furnace installed in the attic area.  
 All visible components were found to be in satisfactory condition at the time of the inspection.

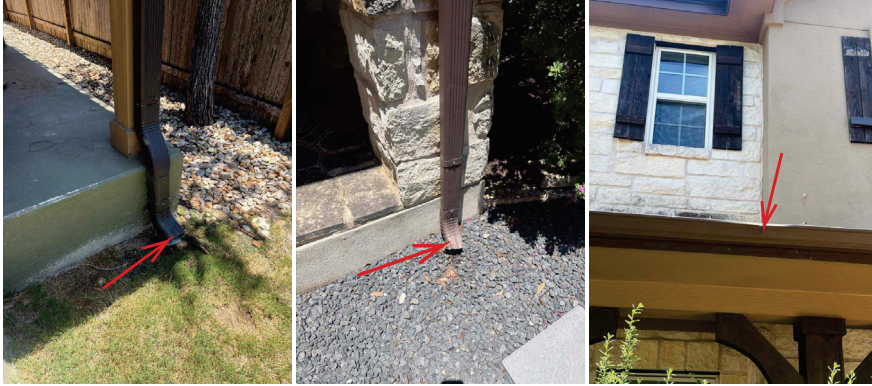
There is a dent in the gutter trough at the front lower eave.

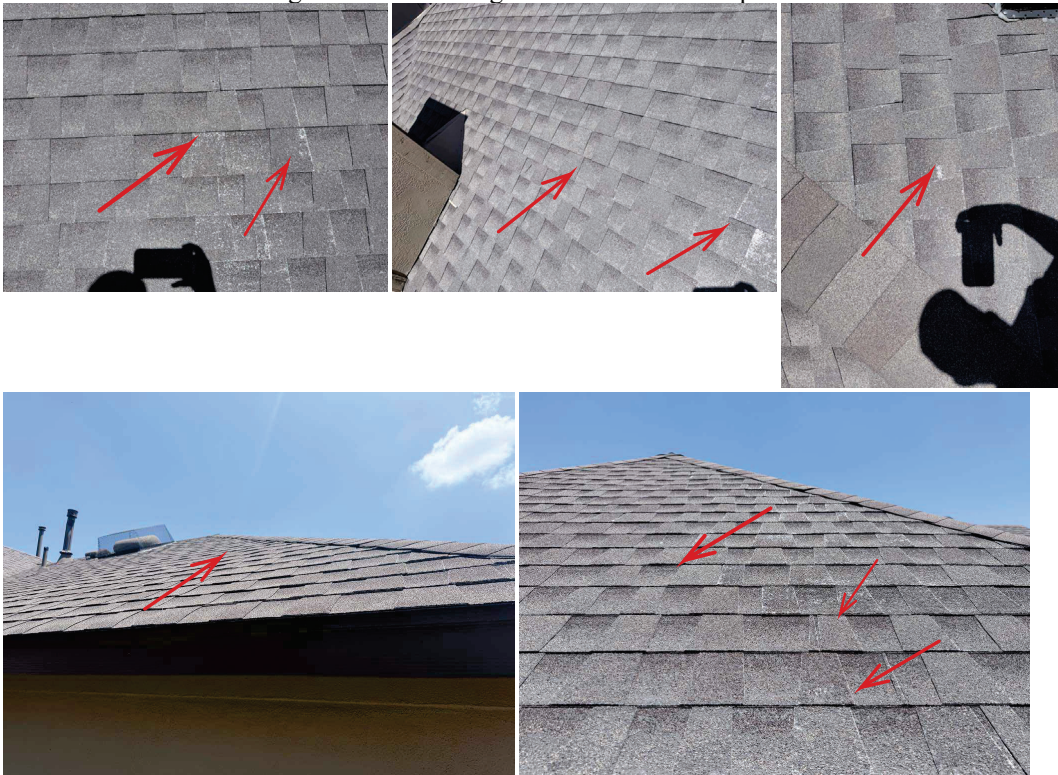
C. Roof Covering Materials There is significant damage and deterioration to the shingles throughout the roof cover.

Recommend contacting a certified roofing contractor to make repairs to the roof and to further evaluate the roof.

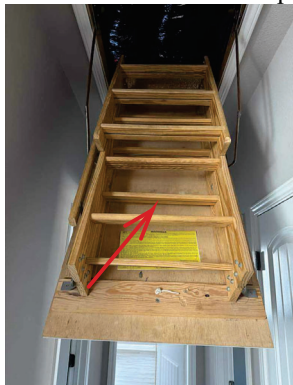
D. Roof Structures and Attics The inspection of the attic area was limited due to limited access.

The upstairs pulldown ladder should be insulated at the attic side to prevent heating and cooling loss.

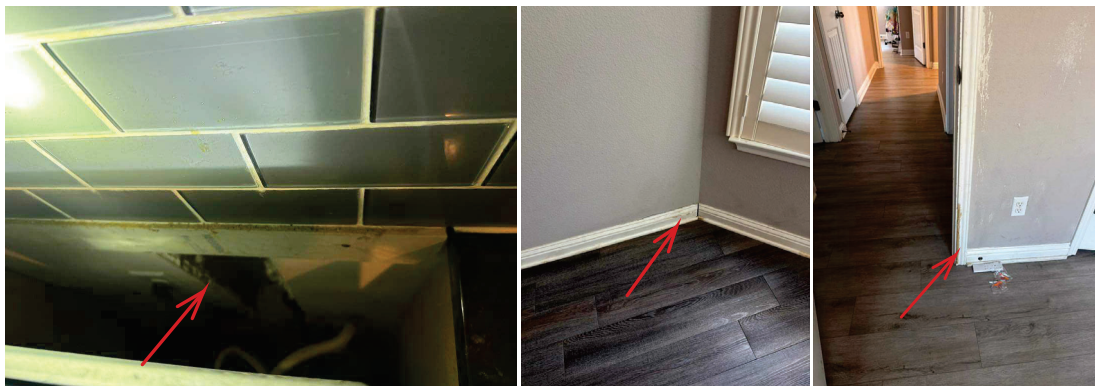
There is deterioration of the baseboard molding at the master bedroom rear wall.

Theres deterioration and damage to the wall trim at the upstairs northside middle bedroom.

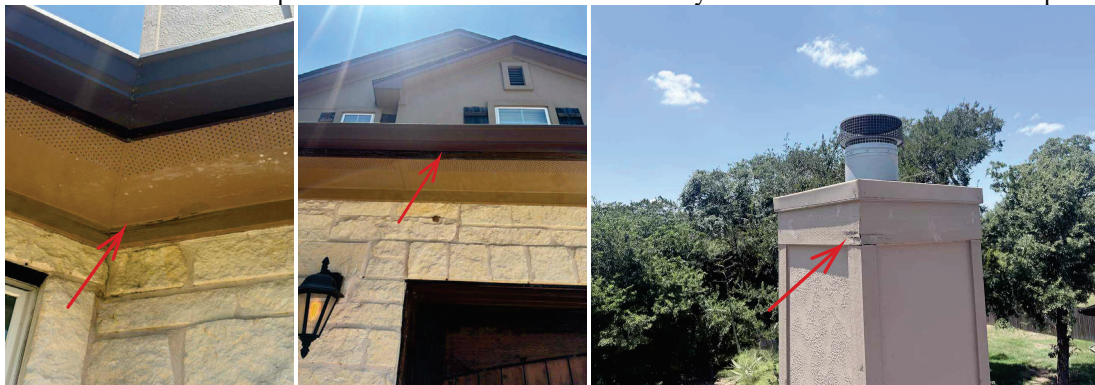
E. Walls (Exterior) There is deterioration of the trim board at the fascia trim rear lower eave.

There is deterioration of the trim board at the upper chimney wall.

There are breaks in the masonry veneer mortar joints at the front garage door wall.

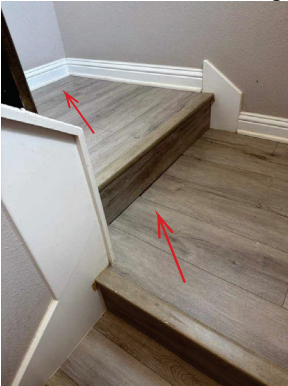
There are loose flooring material at the middle stairway landing area.

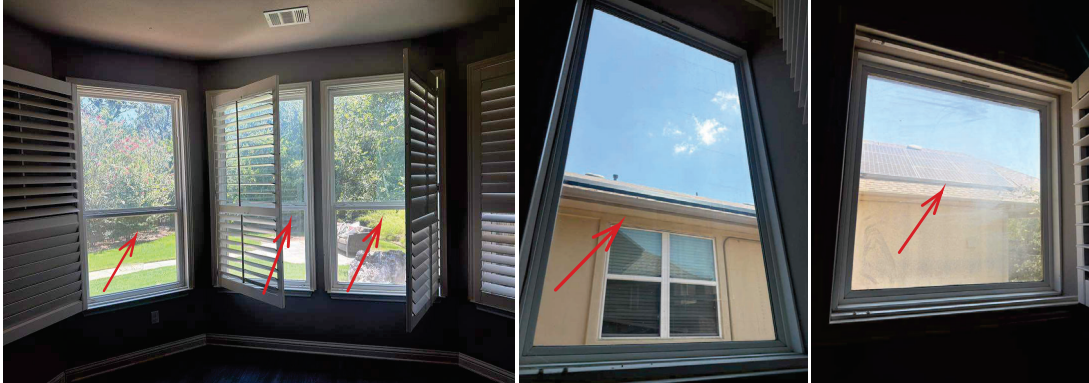
There are three windows at the master bedroom bay wall that have lost the thermal seal and moisture has penetrated between the glass panes.

The window screens were not installed at the time of the inspection.

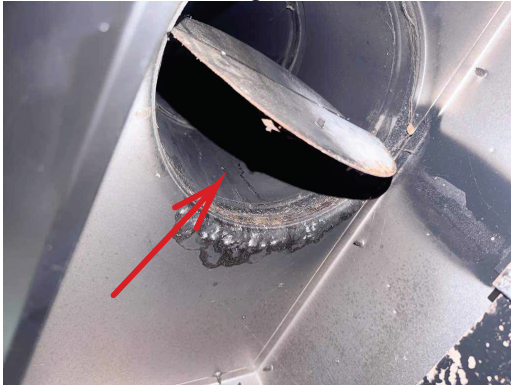
### J. Fireplaces and Chimneys There is a buildup of soot and carbon residue in the flue.

It is recommended that a C clamp be installed on the flue damper to keep the flue from completely closing.

Recommend having the flue cleaned and evaluated before further use.

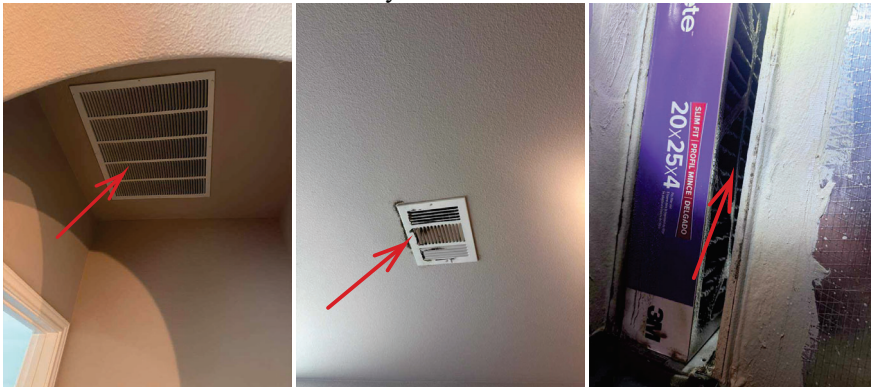
### C. Duct Systems, Chases, and Vents There is a buildup of dirt and lint at the return air vents. Recommend having cleaned.

There is a build up a dirt and stains at the upstairs air supply vents.

The air return filter at the unit in the attic area is dirty and clogged and recommend replacing.

Based on the heavy buildup of dirt and stains at the supply vents and air return filter, it is recommended to have the HVAC system cleaned and further evaluated by a licensed HVAC contractor.

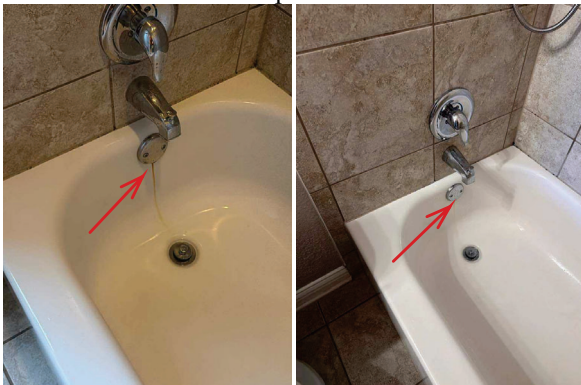
### A. Bathtubs and Shower There is rust at the upstairs guest bathroom tubs at the drain scuppers.

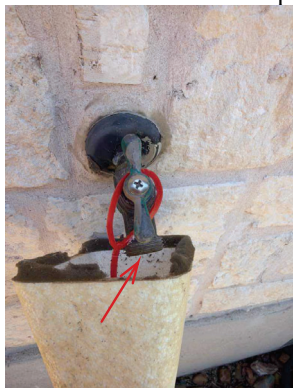
- A. Exterior Plumbing Fixtures The exterior hose bibs do not have back-flow prevention devices.  
All other visible components were found to be in satisfactory condition at the time of the inspection.

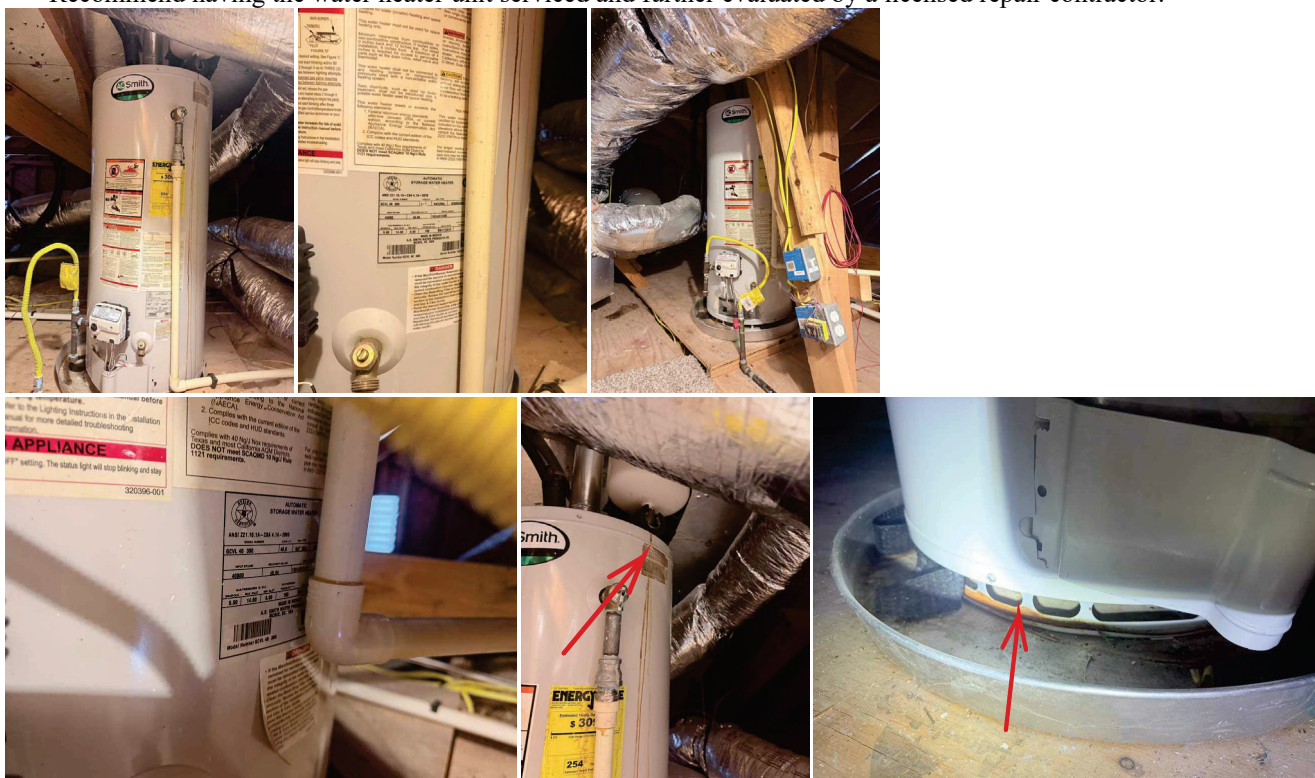
- C. Water Heating Equipment The structure supplied with 2-40 gallon gas water heaters that are installed at the upstairs attic area.  
There are rust stains at both water heater units, indicating previous or current possible leaks at the units.  
All other visible components were found to be in satisfactory condition at the time of inspection.  
Recommend having the water heater unit serviced and further evaluated by a licensed repair contractor.

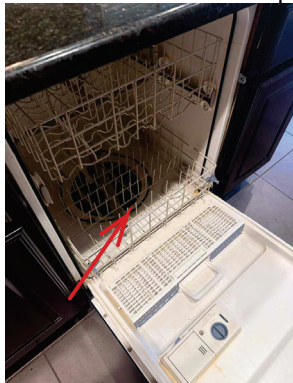
A. Dishwashers There is rust on the racks of the dishwasher.

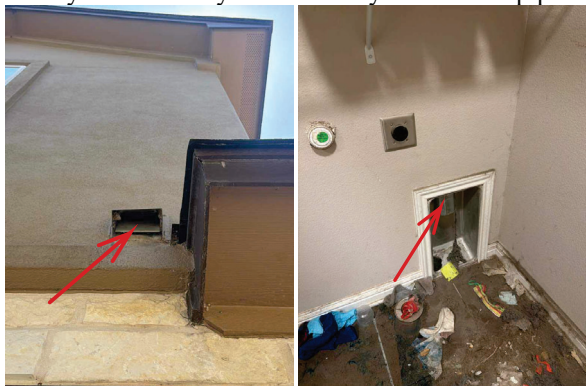
C. Range Hood and Exhaust Systems The filter is dirty/greasy.

H. Dryer Exhaust Systems The dryer vent duct pipe is clogged with lint and should be cleaned before further use.

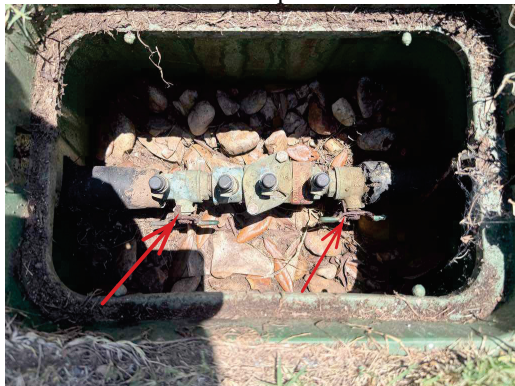
The shut off handles for the backflow preventer valve are rusted on and are in need of repair.
